**Re: Environmental Assessment after Fire Loss**

Location: 195 Simcoe Street North, Oshawa, ON

Our File: 191361CDM

**Project Name:** Environmental Assessment after a Fire Loss, 195 Simcoe Street North, Oshawa, Ontario

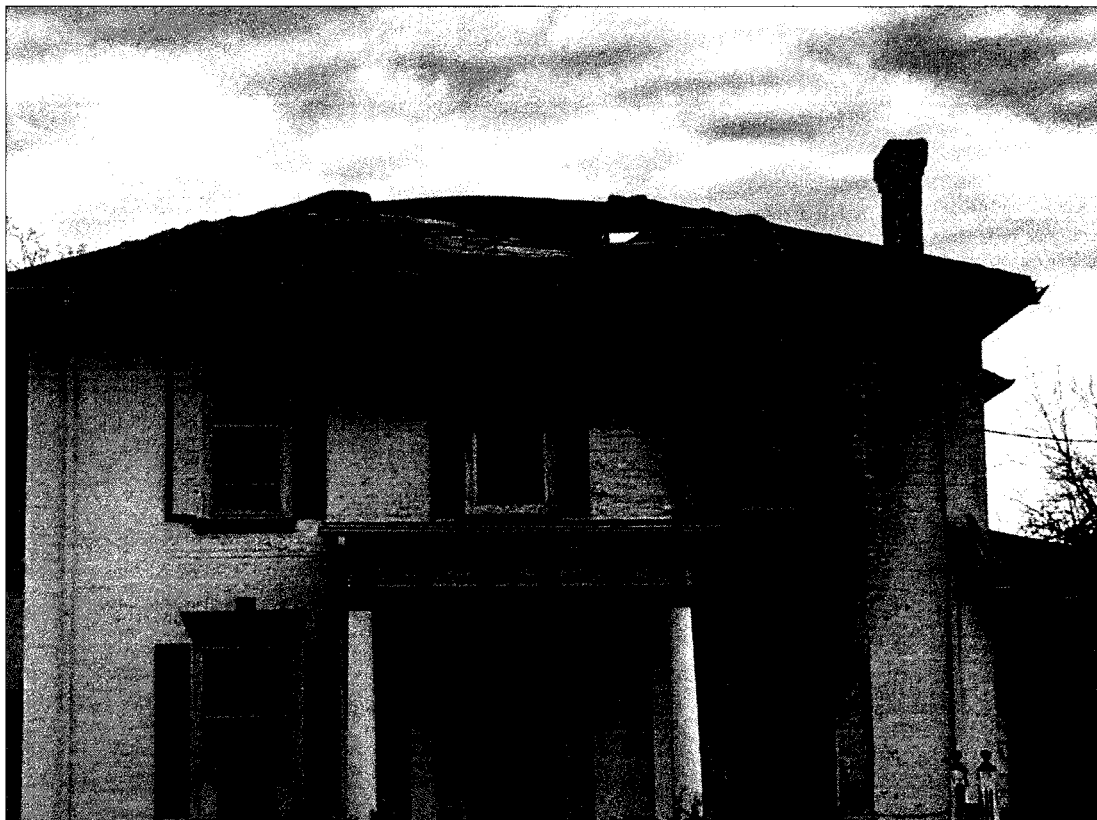
- The southwest elevation of the building was partially consumed by the fire.
- The roof of the building was partially consumed by the fire, extensively damaged, and open to the outdoors. The construction of the roof had deteriorated further during the time between our first and second site visits, and the hole in the roof had begun to collapse in on itself, nearly doubling in size.

**Figure 1: View of front exterior of subject house and roof consumed by fire**

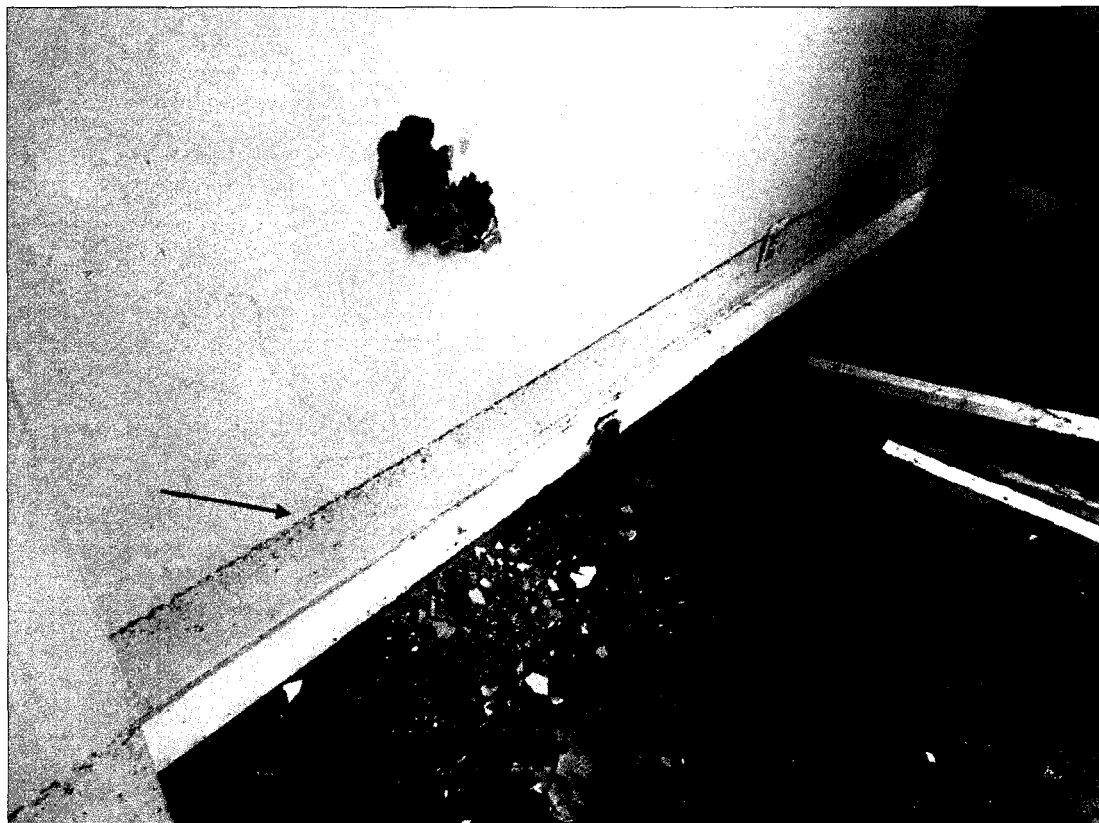
- There was a water stain at approximately 12 inches above the main level floor, indicating that at one point there would have been approximately 12 inches of standing water on the main level. Electrical sockets within this 12-inch range were plugged with debris from the water damage throughout the main level.

**Figure 8: View of water staining line throughout main level and smoke impacted wall finishes in northeast bedroom (Sample S-4)**

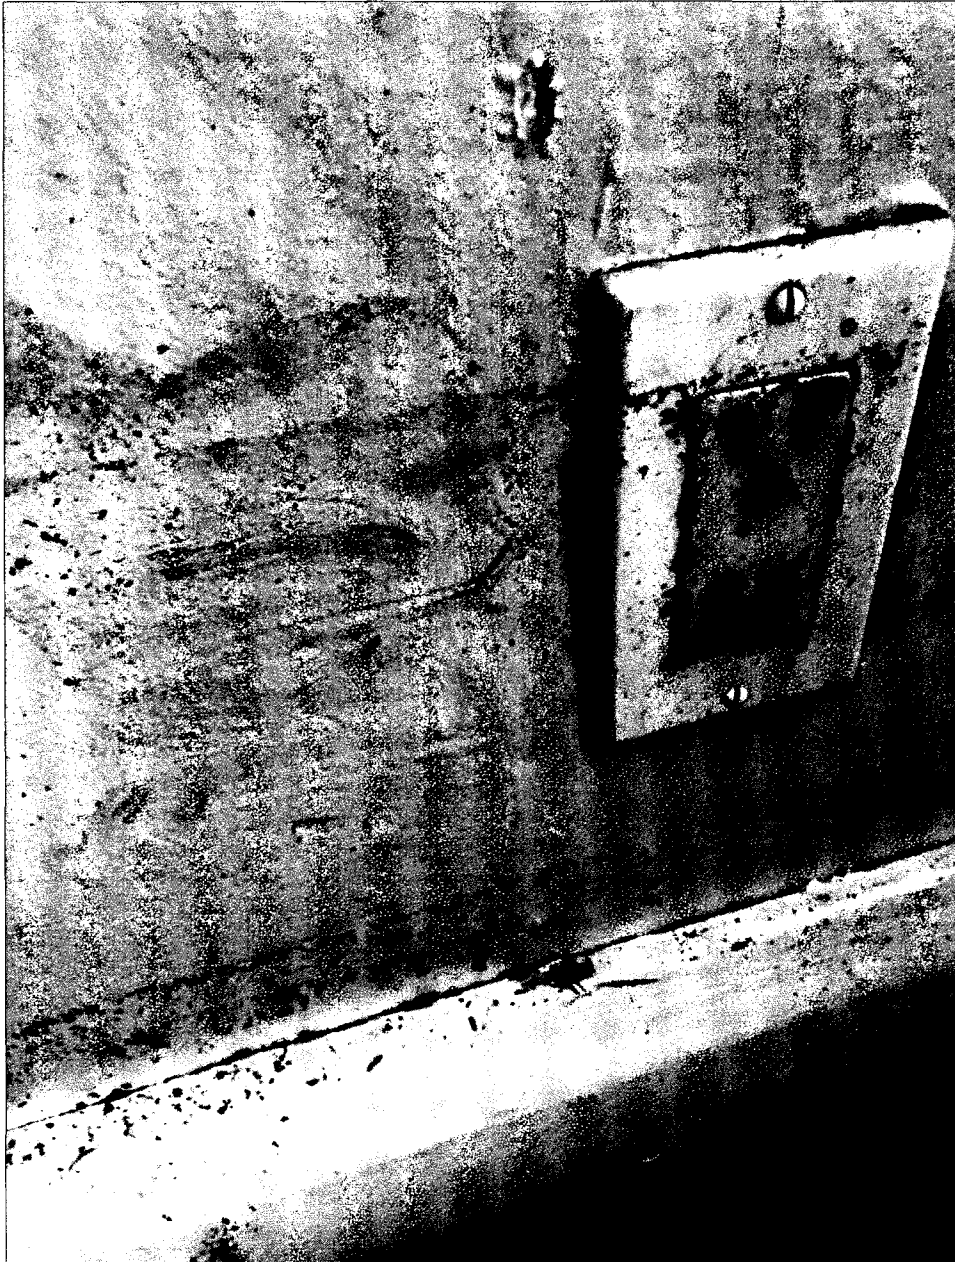
**Figure 9: View of electrical socket plugged with debris**

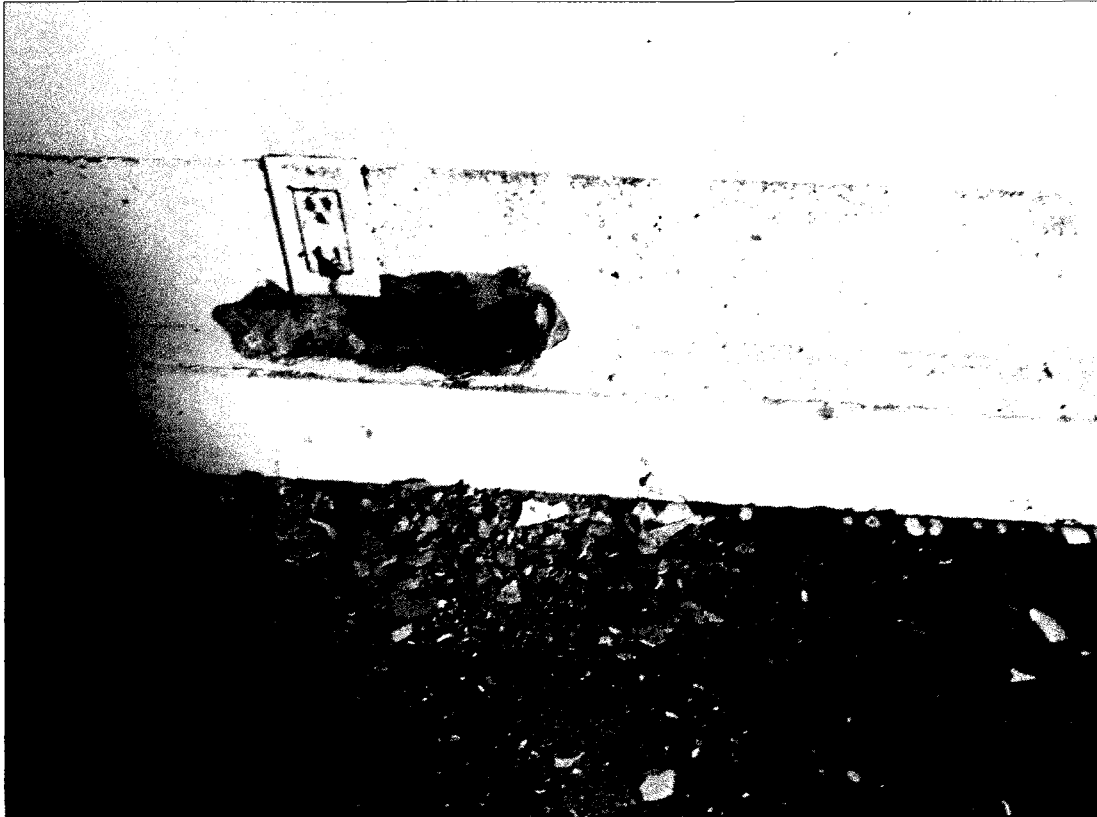
**Figure 12: View of smoke impacted perimeter wall cavity in main level northeast bedroom (Sample B-2)**
