Public Report

То:	Joint Community Services/Finance Services Committee
From:	Ron Diskey, Commissioner, Community Services, Community Services Department
	Stephanie Sinnott, Commissioner, Finance Services, Finance Services Department
	Tracy Adams, Commissioner, Corporate Services, Corporate Services Department
Report Number:	CS-19-120
Date of Report:	October 2, 2019
Date of Meeting:	October 7, 2019
Subject:	Redevelopment Plan for Rotary Park
File:	E-4010

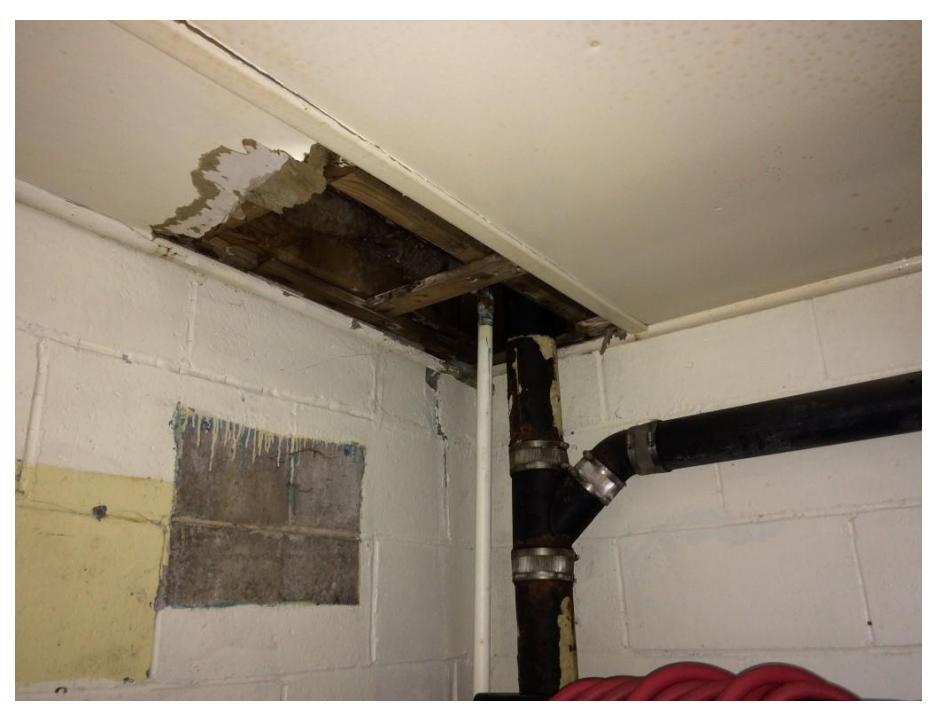
Photograph No. 13: Typical Damage on Interior Finishes

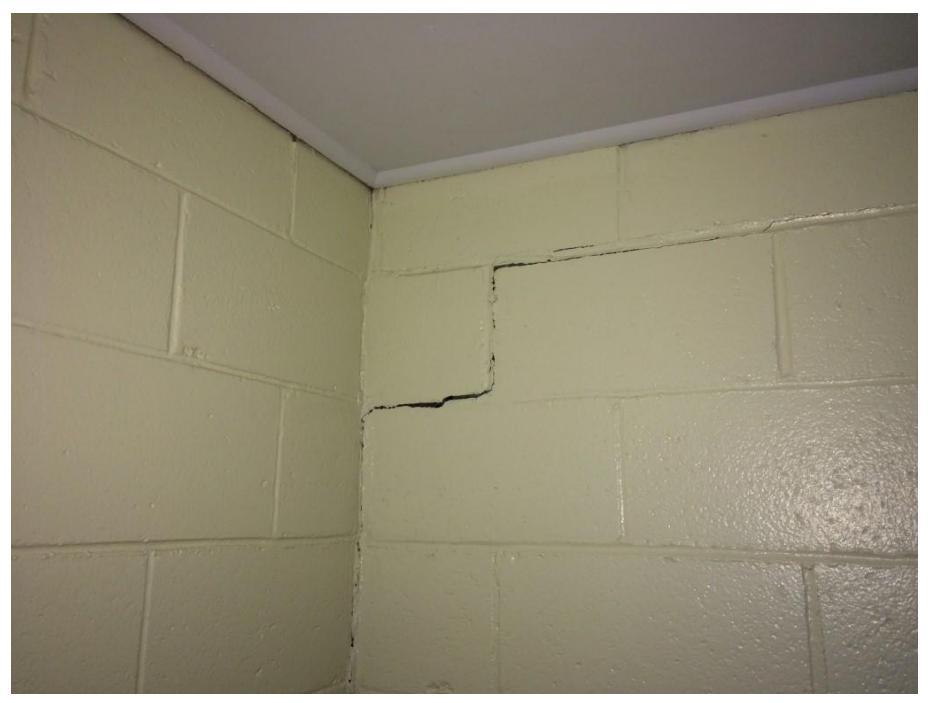
Photograph No. 14: Typical Cracking of Interior Masonry Walls

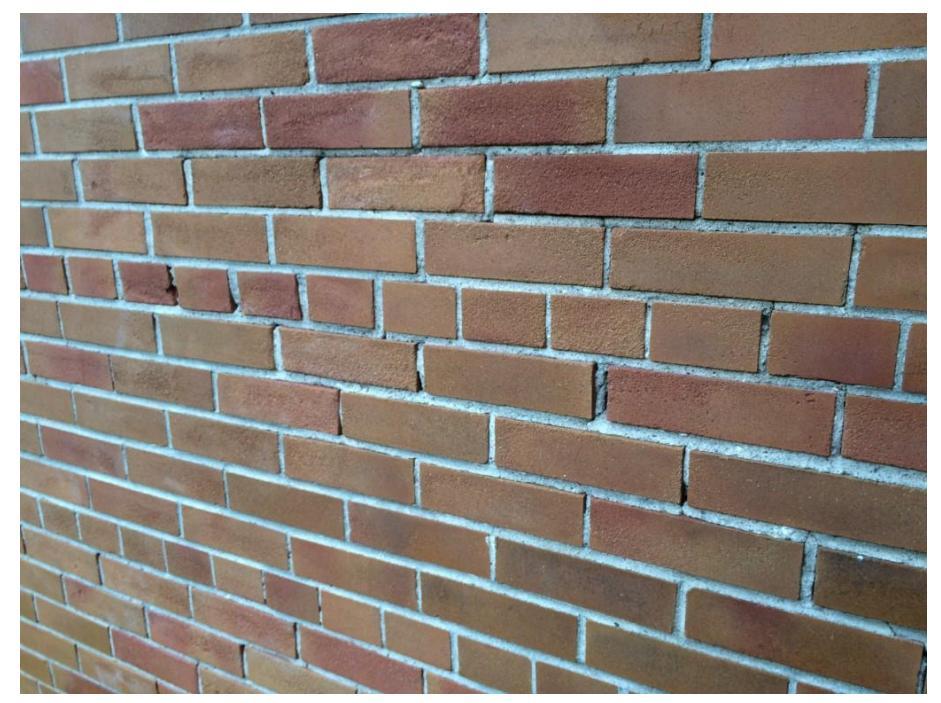
Photograph No. 15: Typical Mortar Joint Deterioration – Original Building

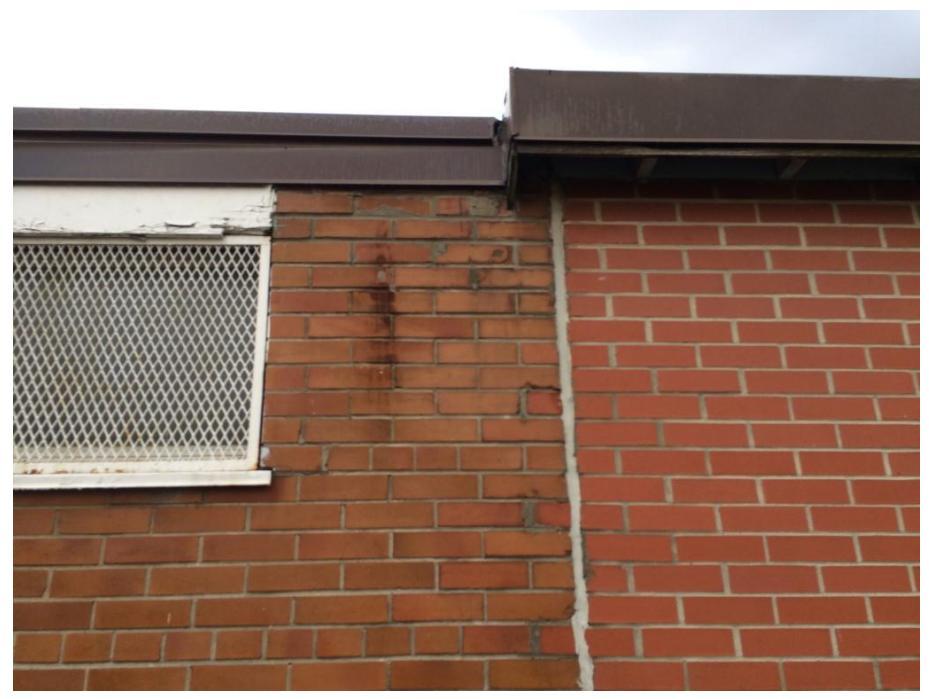
Photograph No. 16: Typical Brick Unit Deterioration – Original Building

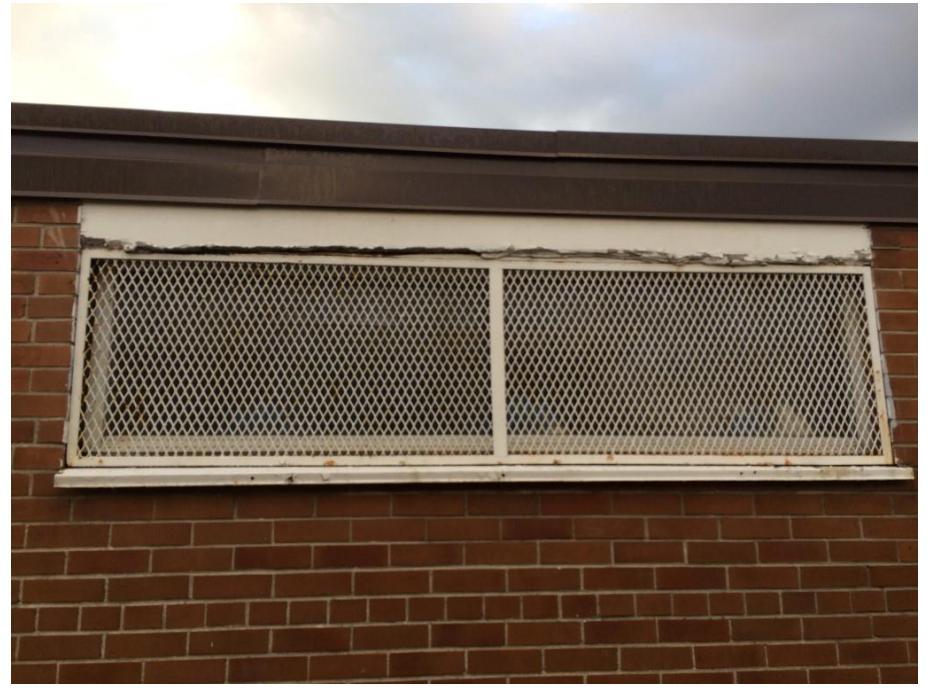
Photograph No. 17: Overview of Lintel Deterioration – Original Building

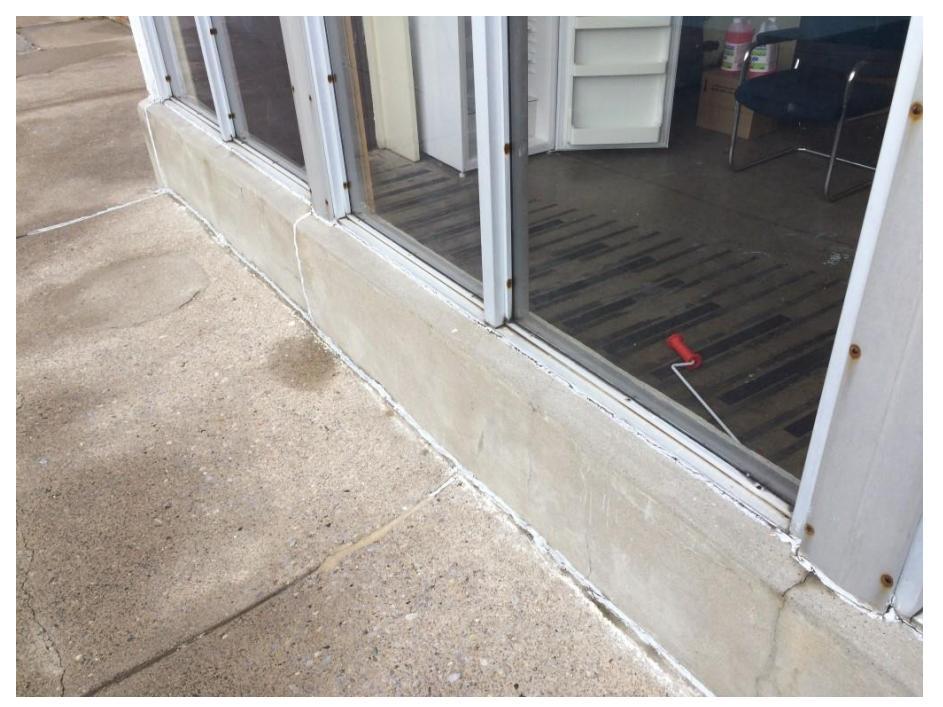
Photograph No. 18: Typical Deterioration of Perimeter Sealant

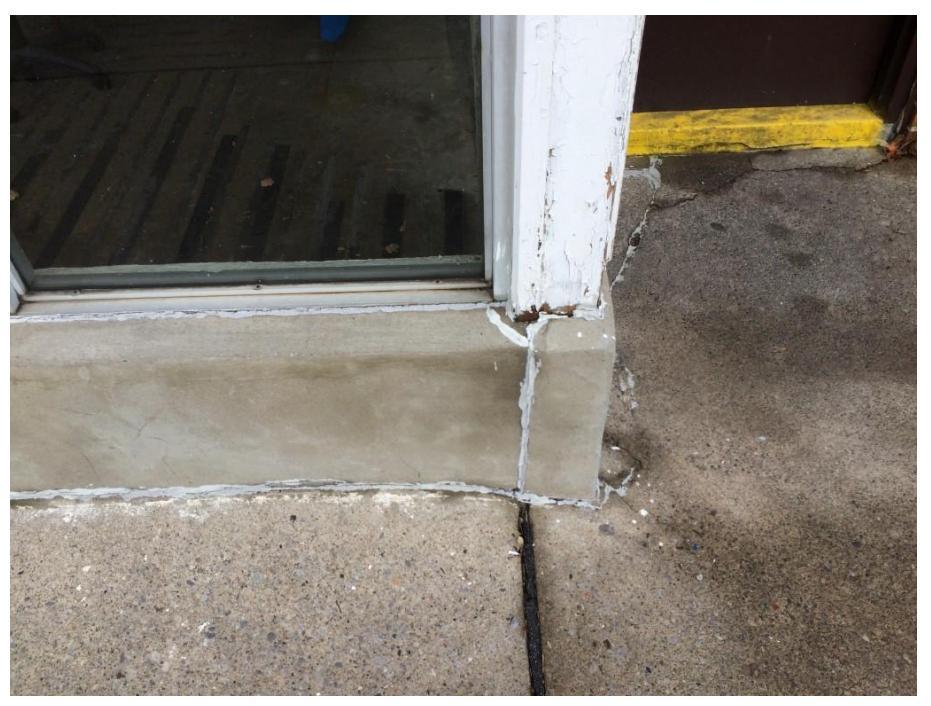
Photograph No. 19: Typical Deterioration of Window Frame

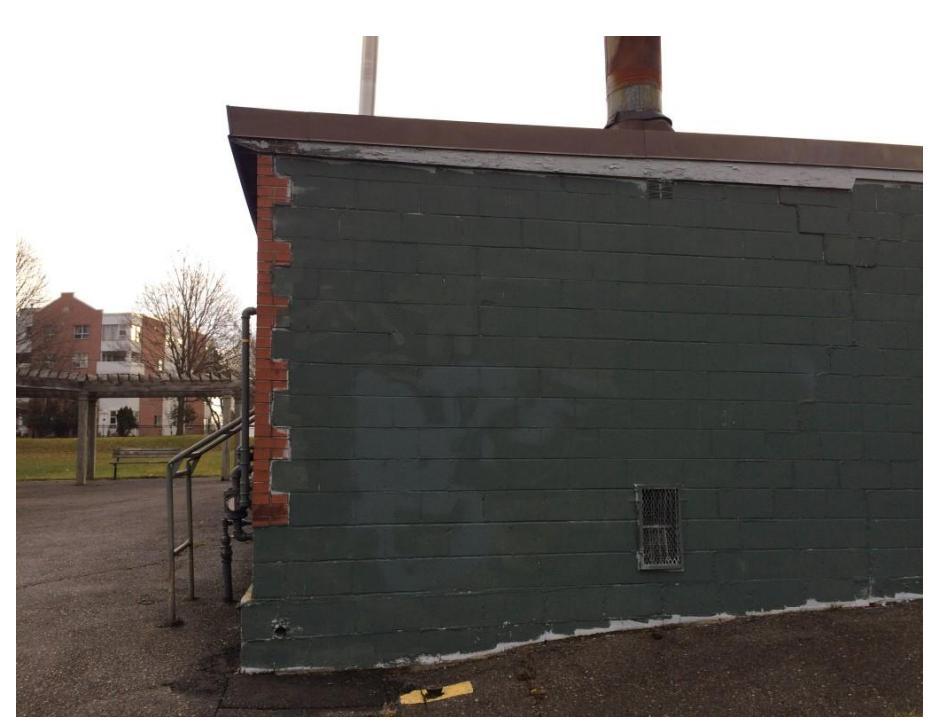
Photograph No. 20: Typical Deterioration in Mechanical Room – Exterior Wall Cracking

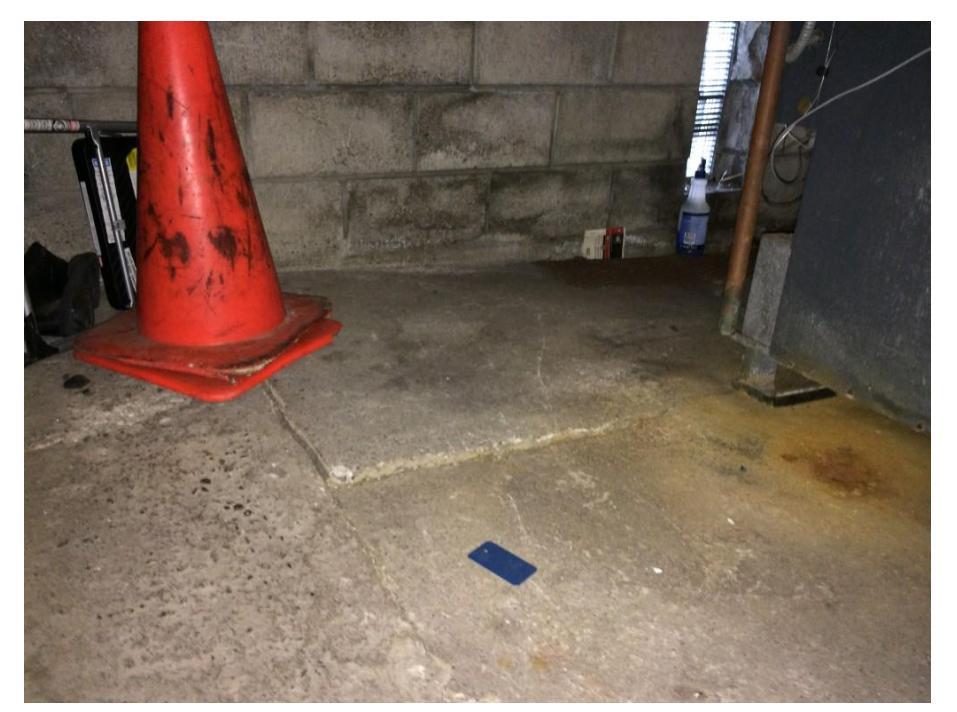
Photograph No. 21: Typical Deterioration in Mechanical Room – Slab-on-Grade Settlement

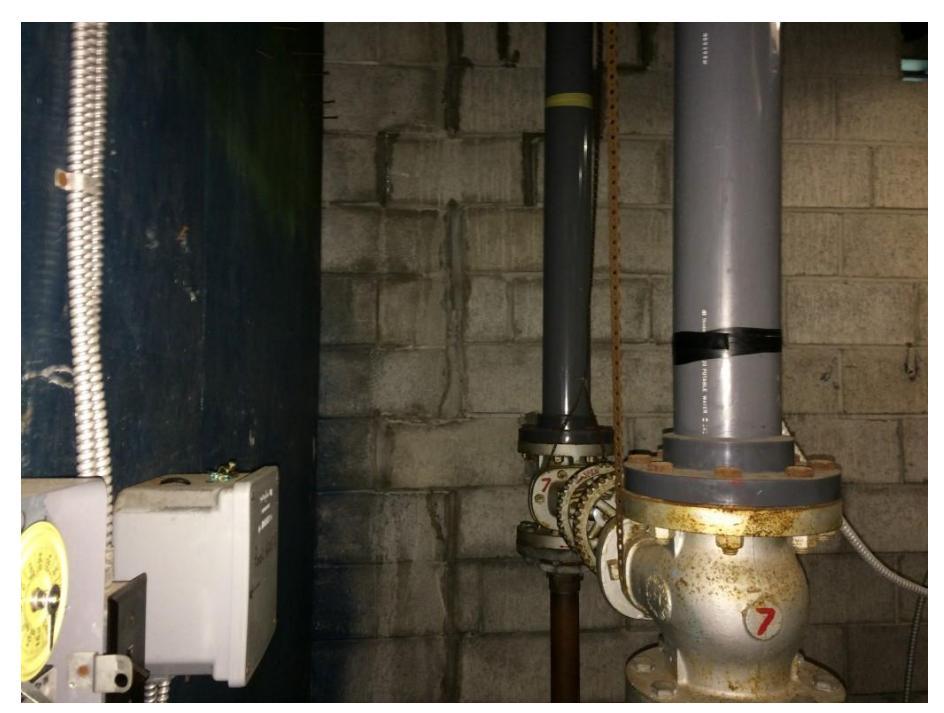
Photograph No. 22: Typical Deterioration in Mechanical Room - Interior Wall Crack

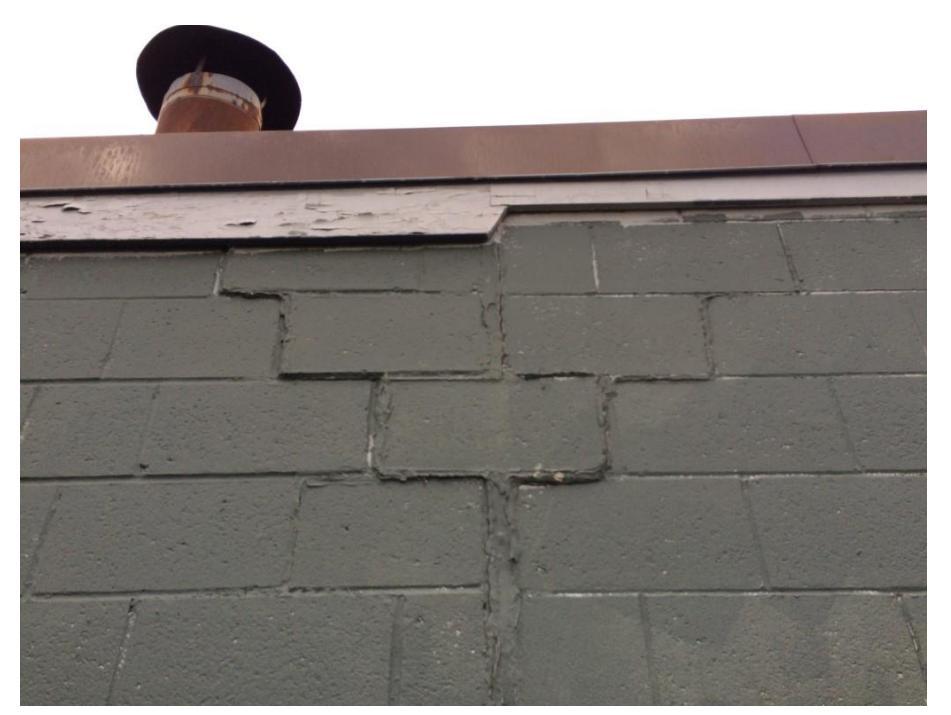
Photograph No. 25: West Wall Deterioration - Mechanical Room

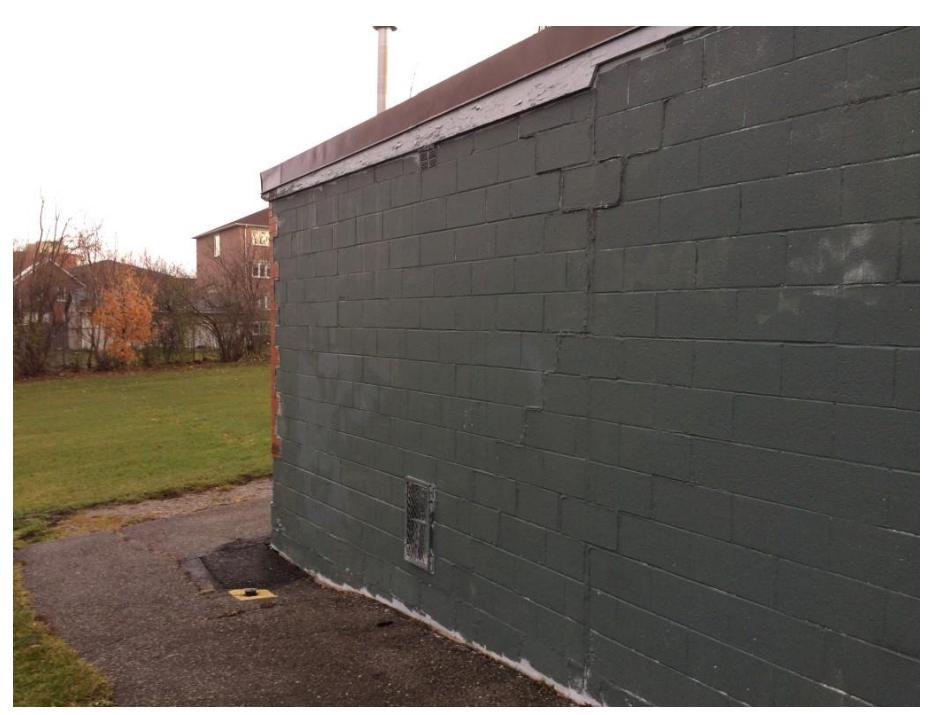
Photograph No. 26: West Wall Deterioration - Mechanical Room

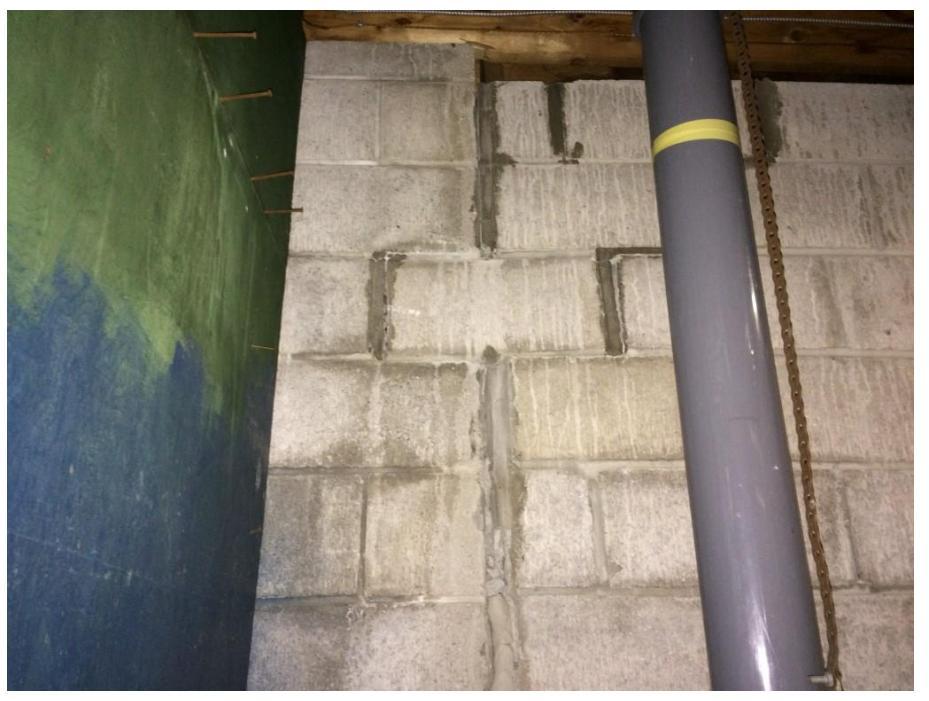
Photograph No. 27: West Wall Deterioration – Mechanical Room

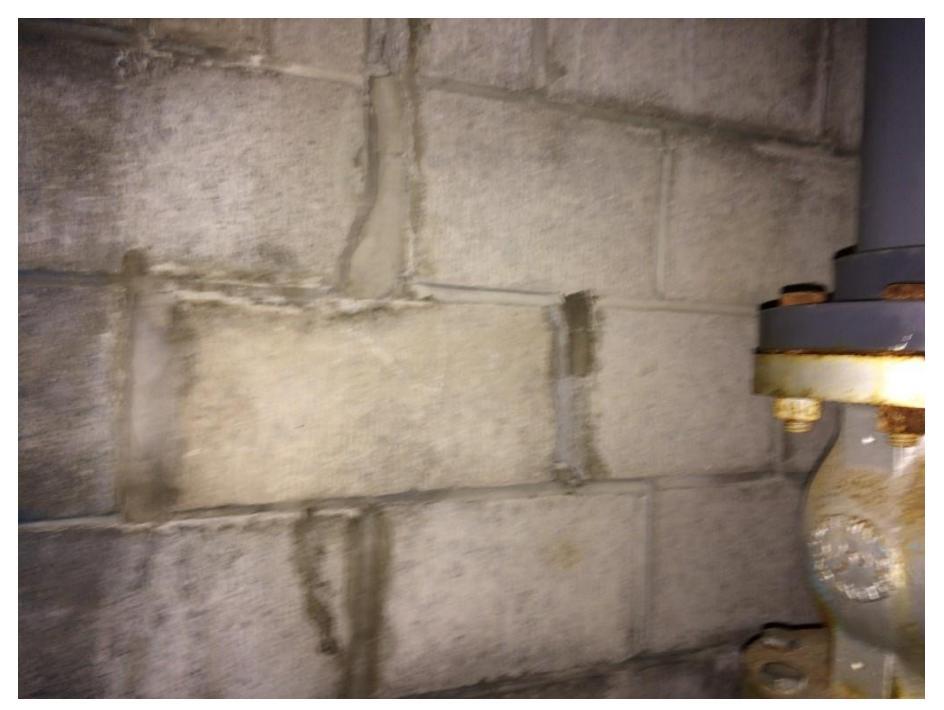
Photograph No. 28: Evidence of Previous Repairs – West Wall

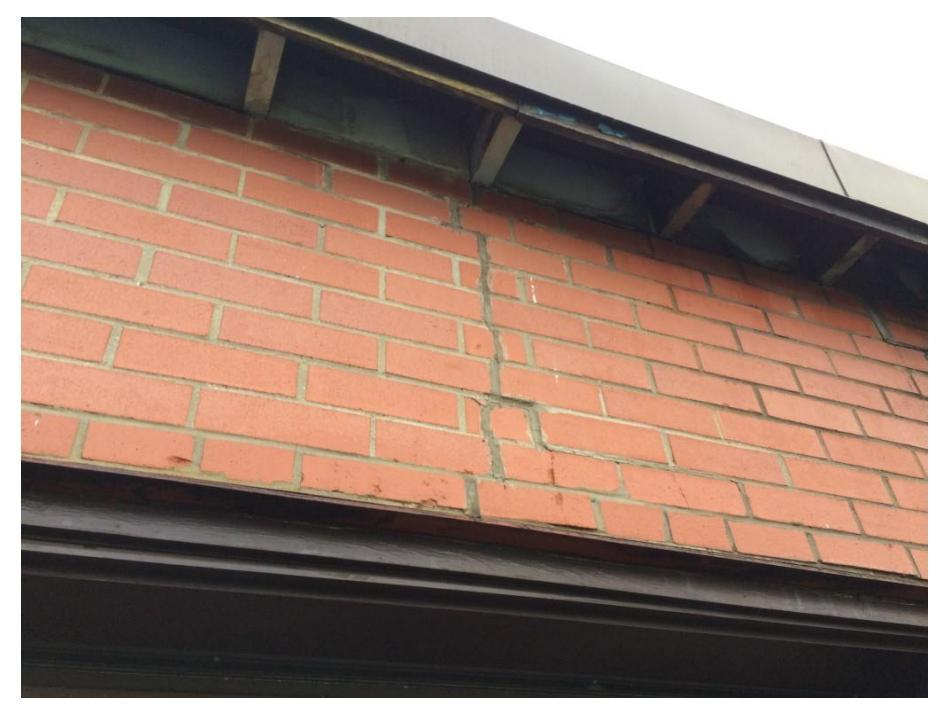
Photograph No. 29: Brick Veneer Cracking above Overhead Door – Mechanical Room Exterior

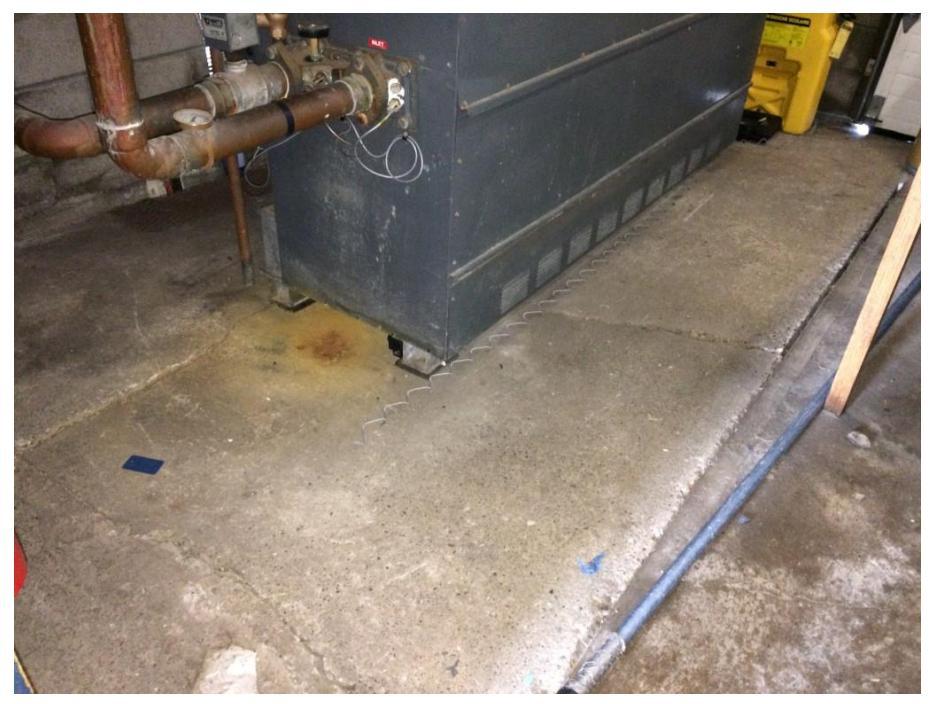
Photograph No. 31: Mechanical Room – Slab-on-Grade Cracking

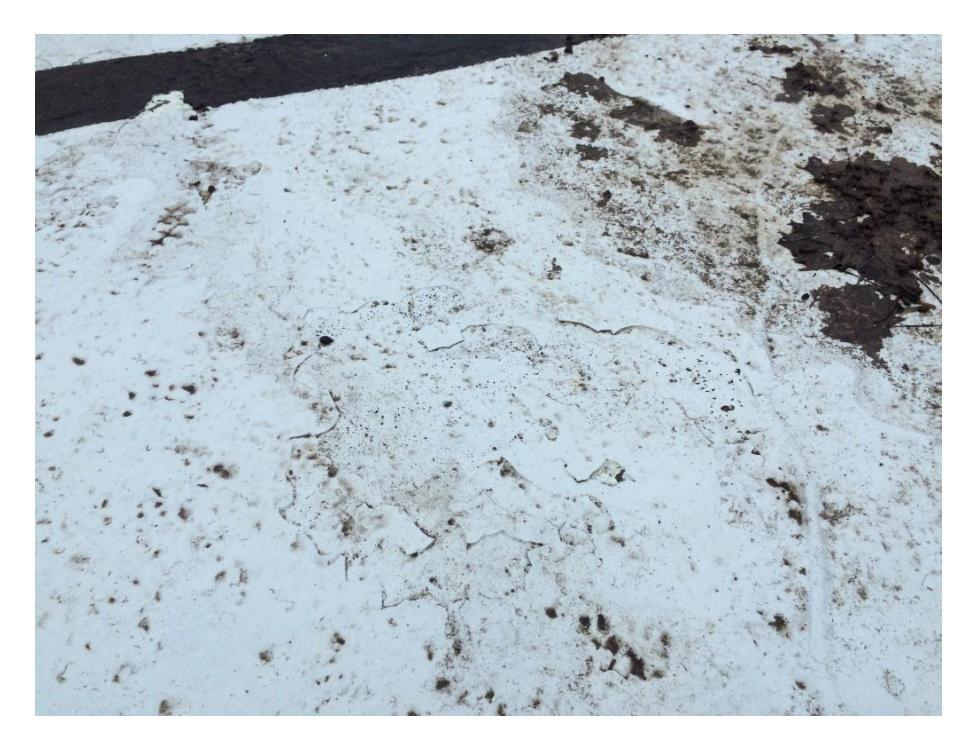
Photograph No. 32: Typical Deterioration of Pool Shell - Concrete Spalls

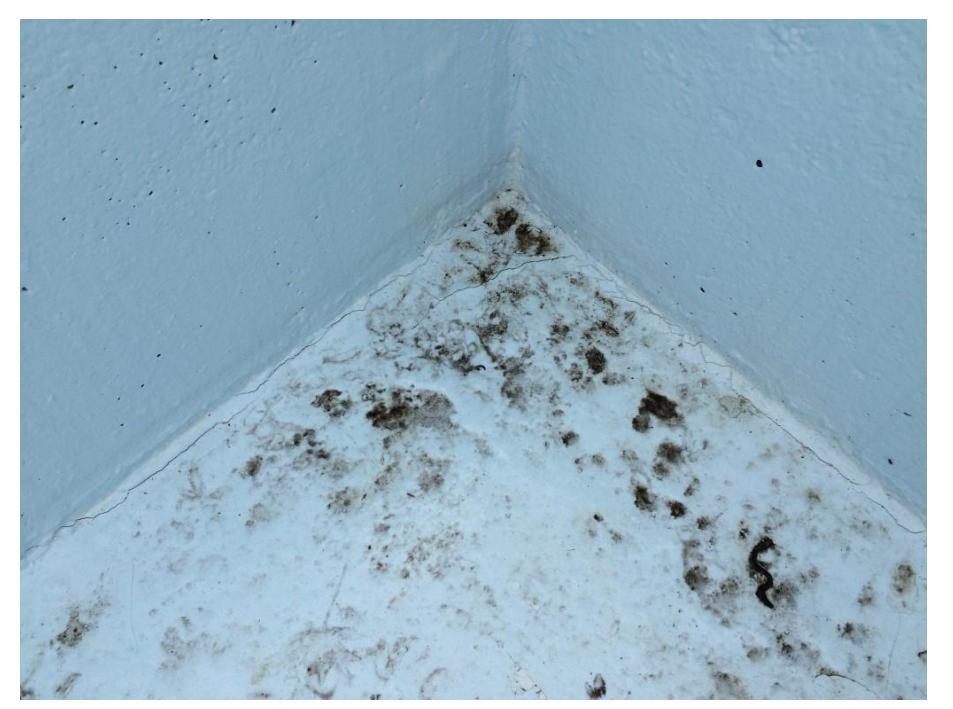
Photograph No. 33: Typical Deterioration of Pool Shell – Cracked Coating

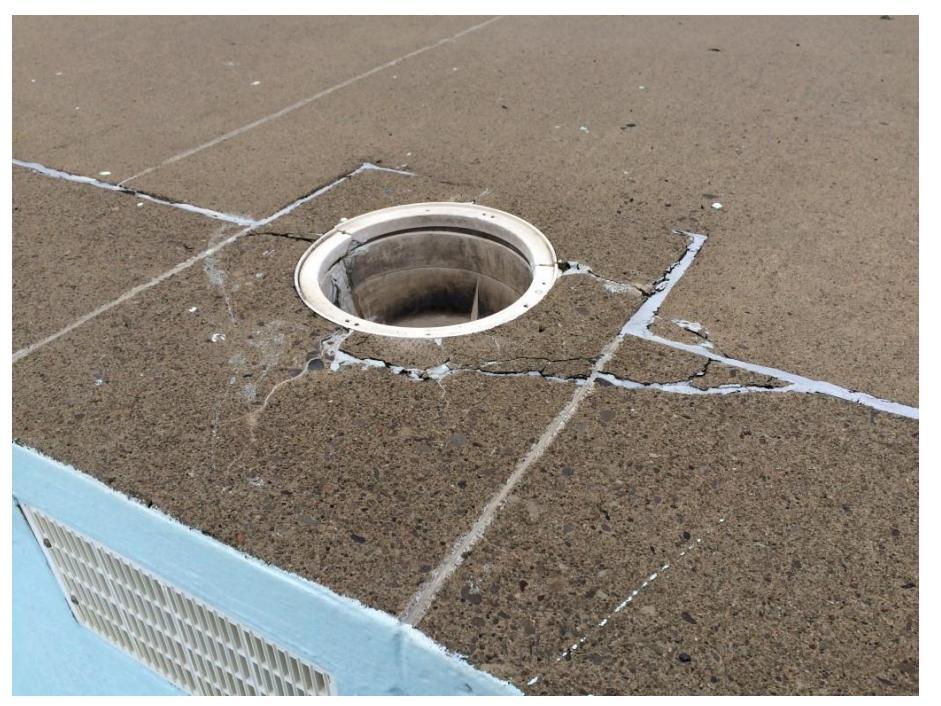
Photograph No. 35: Typical Pool Dec Deterioration

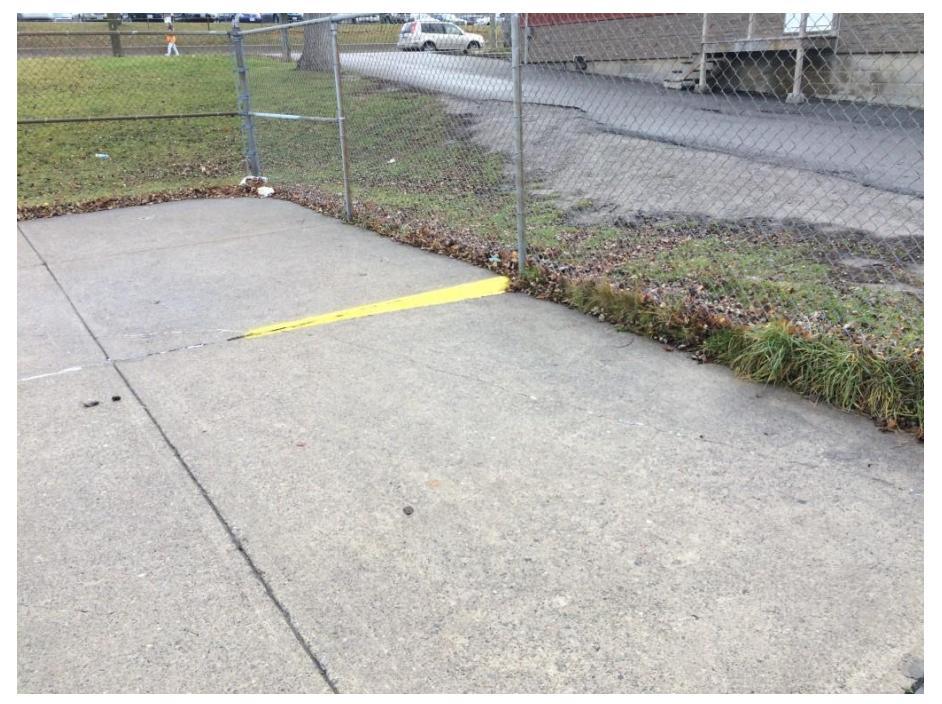
Photograph No. 36: Typical Pool Dec Deterioration

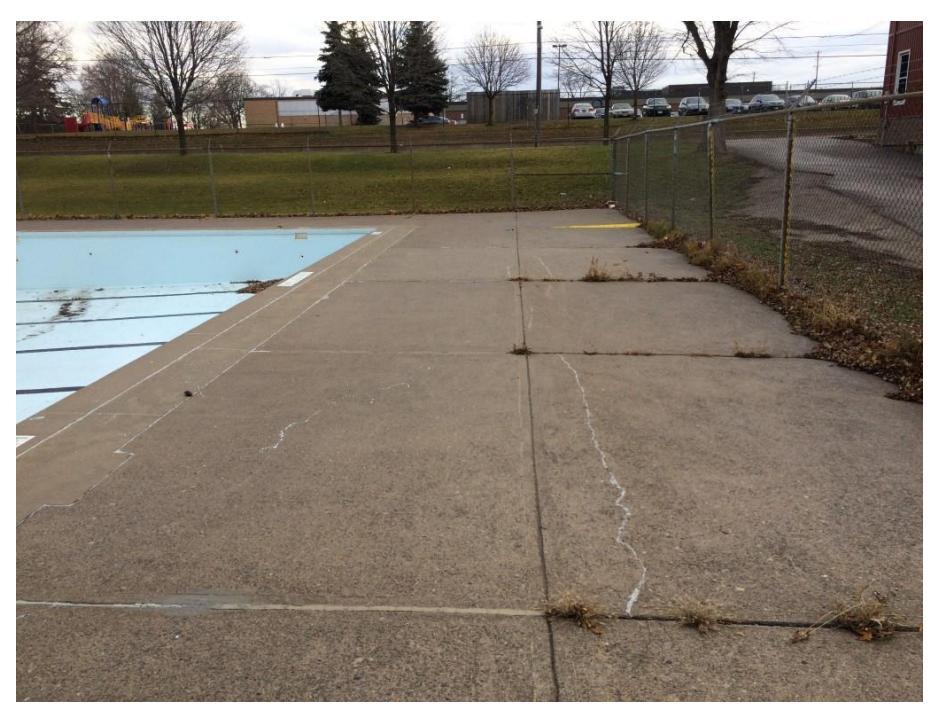
Photograph No. 37: Typical Pool Dec Deterioration

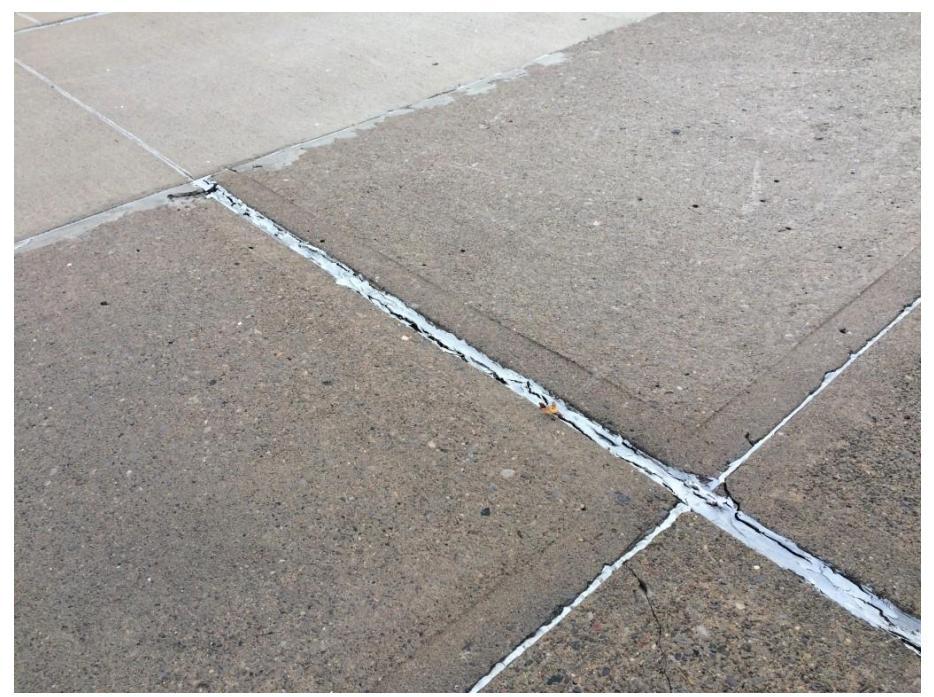
Photo 38: Failed Joint Sealant – Pool Deck

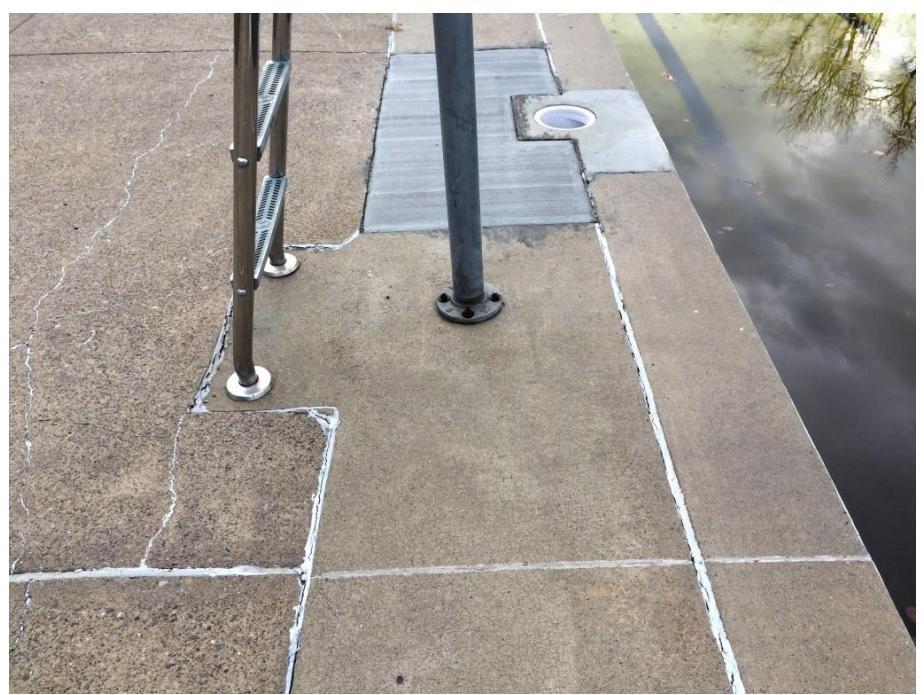
Photo 39: Failed Joint Sealant – Pool Deck

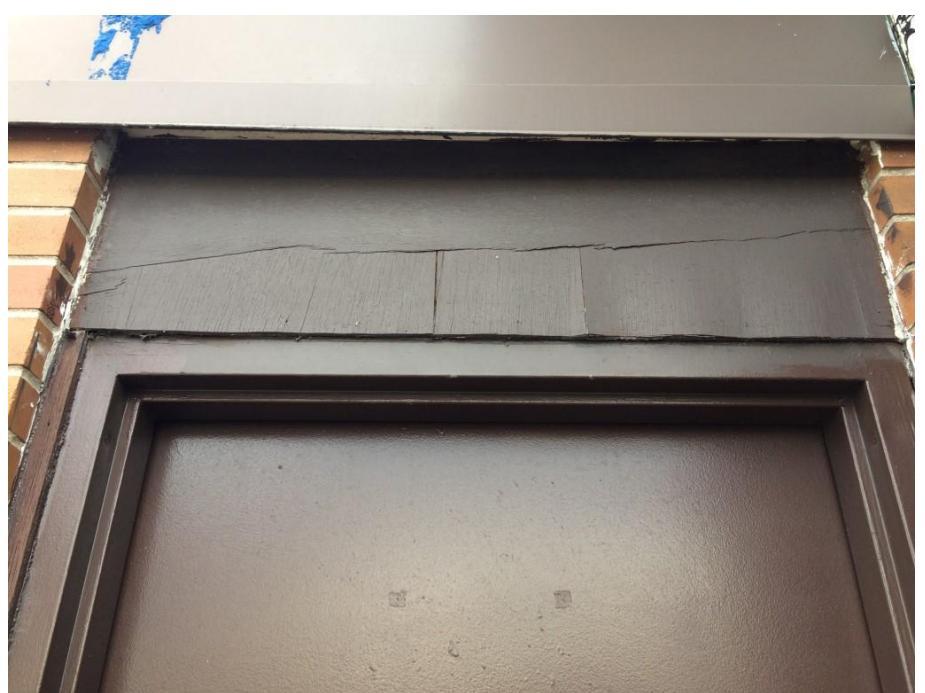
Photo 40: Damaged Door Sheathing

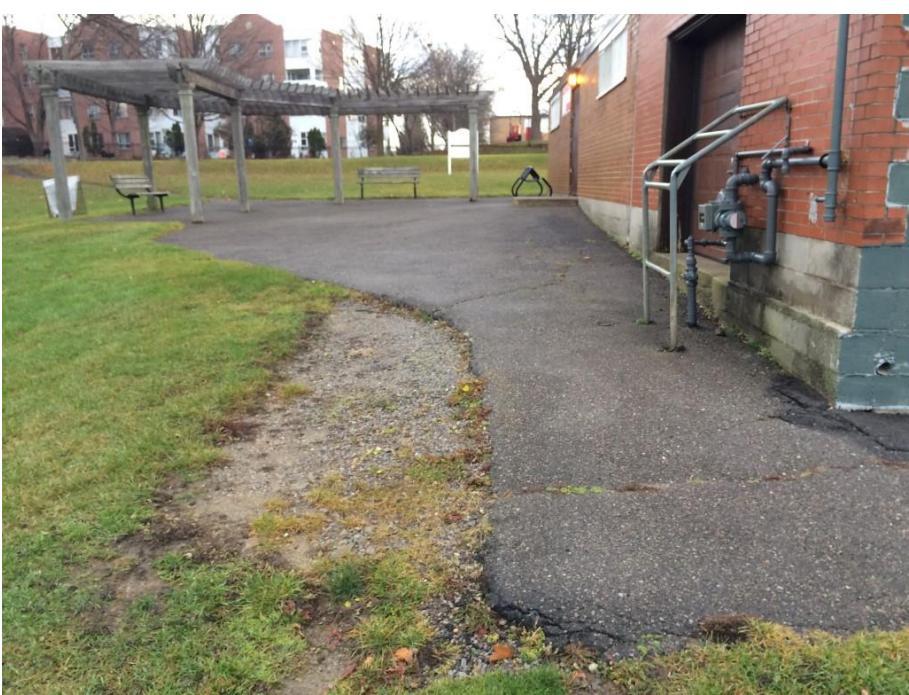
Photo 41: Deteriorated Asphalt

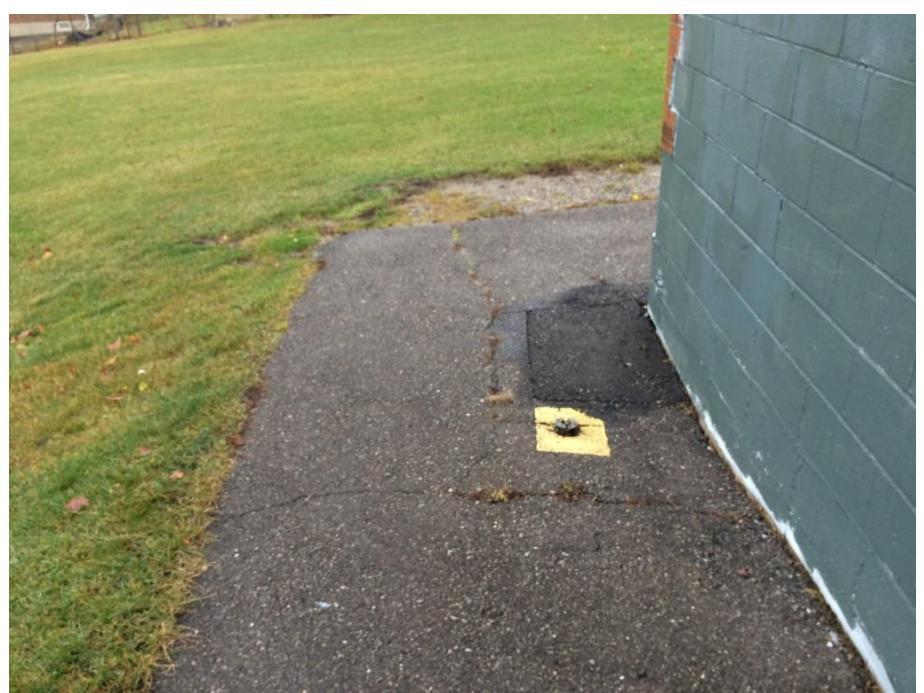
Photo 42: Deteriorated Asphalt

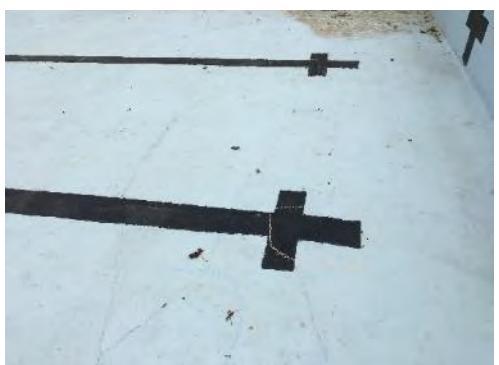
The pool structure appears to be in good to fair condition considering its age, however, there was evidence of age related deterioration in the form of cracks in the pool liner and spalling sections of the pool surface. The pool did not appear to have a waterproofing membrane, as the liner appeared to consist of paint coating. Approximately 115 lin.ft. of pool surface cracks were observed, with a majority of them located within the southern shallow end part of the pool. Discussions with City of Oshawa staff on site revealed that trees were previously located on the south side of the Rotary Pool complex, and that the roots are still present underneath the

Figure 2: Overview of cracked pool liner at south end of Rotary pool

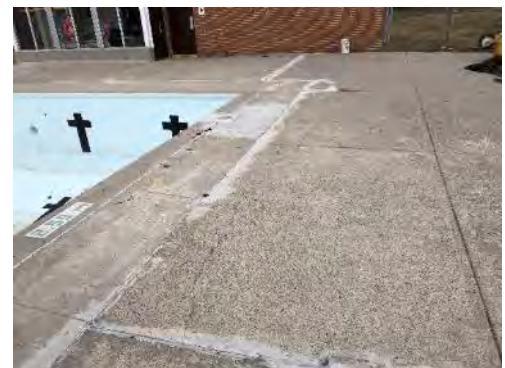
The existing concrete pool deck appeared to be in fair to poor condition, exhibiting evidence of movement related deterioration in the form of cracked and settled pool deck concrete panels (*Refer to Figure 3 and Photographs No.8 to No.11 in Appendix A*). Our review indicated that 47 panels were cracked, with approximately 580 lin.ft. of cracks total. Along the east section of the pool deck in particular, continuous 80-foot and 50-foot north-south cracks in the concrete panels were observed. These north-south cracks are another indication of settlement within the panels, as the panels appeared to be sloped away from the pool in comparison to

Figure 3: Overview of pool deck cracks

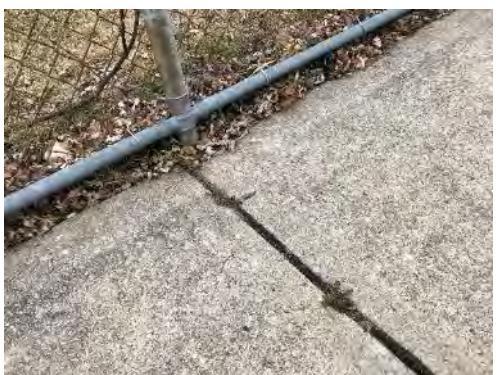
RJC also reviewed the joint sealant around the pool deck. In general, the sealant appeared to be in poor condition, with widespread failure of the sealant material. The joints between the concrete panels appeared to be filled with a concrete and rubberized material, while the joints around the perimeter of the pool where the mechanical systems are located appeared to be filled in with caulking (*Refer to Figure 4 and Photographs No.17 to No.19 in Appendix A*). Discussions with staff members from the City of Oshawa indicated that these joints were previously repaired each year by the City of Oshawa with Sikaflex material, but last year they were filled by an independent contractor with an unknown material. Plant

Figure 4: Overview of plant growth and rubberized material in joint.

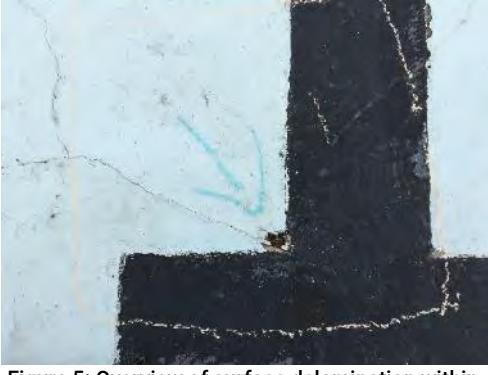
Figure 5: Overview of surface delamination within pool

70 sq.ft of hollow sounding areas within the pool tank (*Refer to Figure 5 and Photograph No. 21 in Appendix A*).

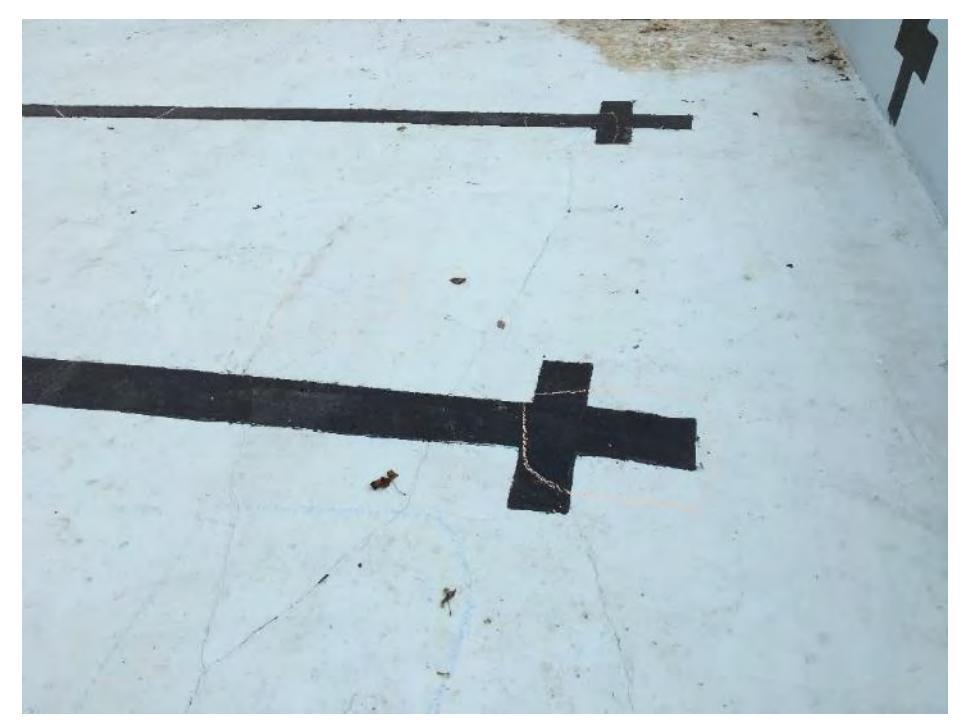
Photograph No. 4: Overview of cracked pool liner at south end of Rotary pool.

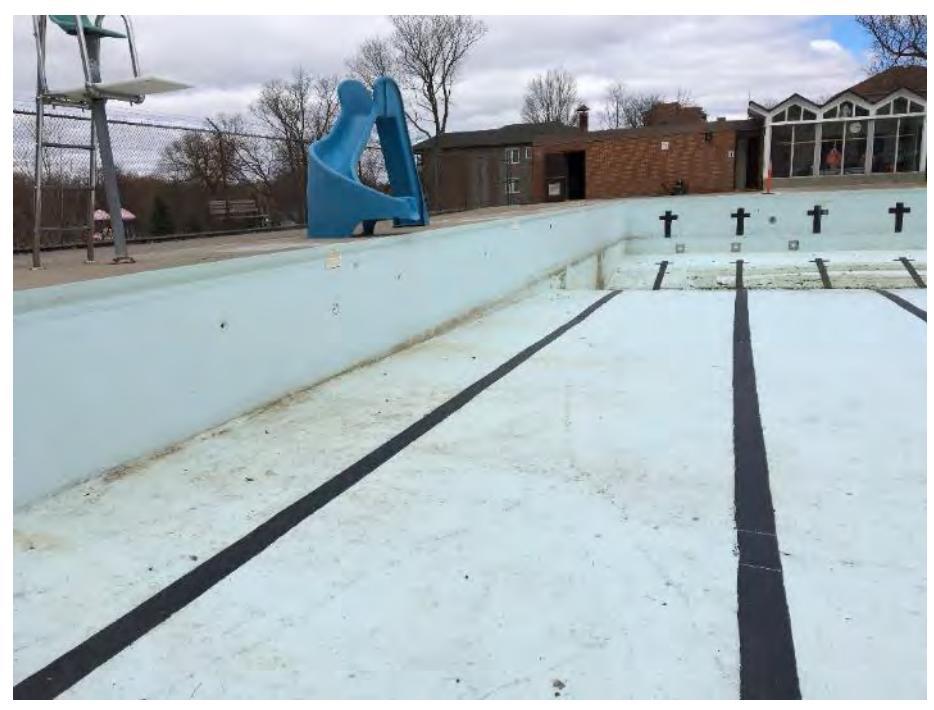
Photograph No. 5: Overview of cracked pool liner.

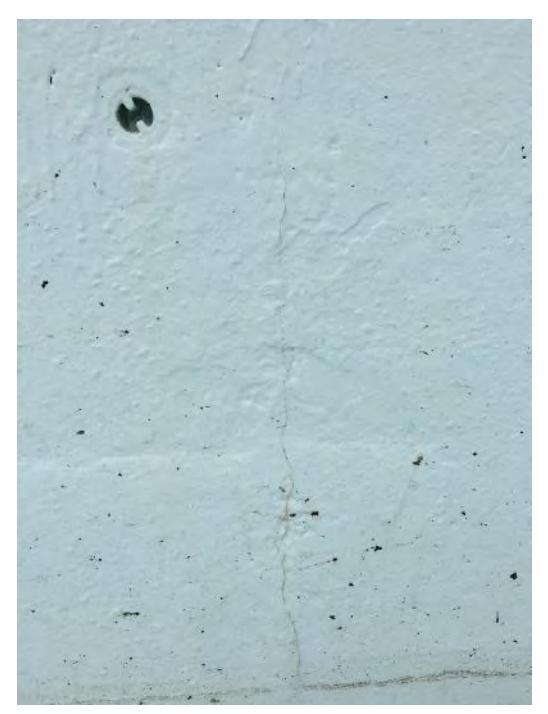
Photograph No.6: Overview of pool wall leaking crack on west wall of pool.

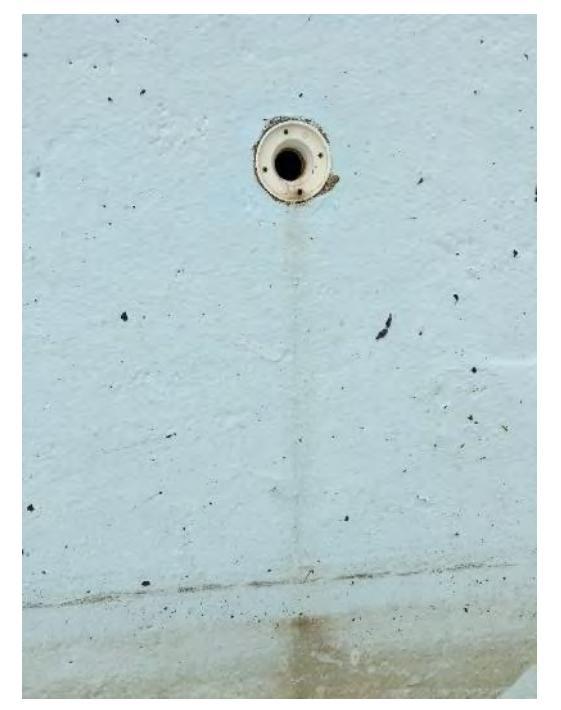
Photograph No.7: Overview of installed pool penetration without waterproofing membrane clamp.

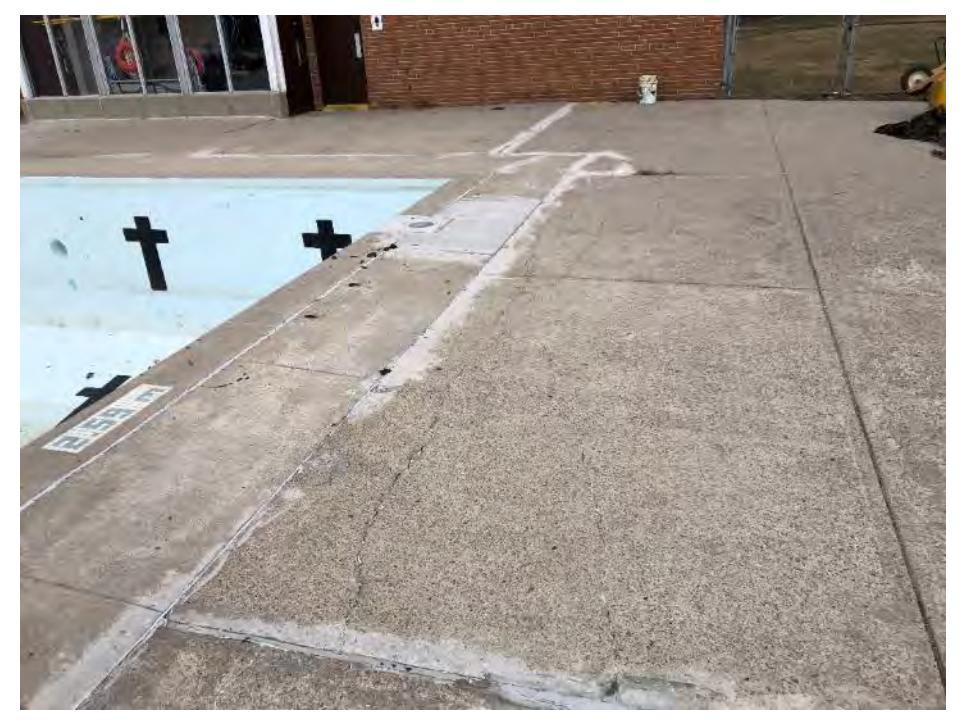
Photograph No. 8: Overview of pool deck cracks at north-west side.

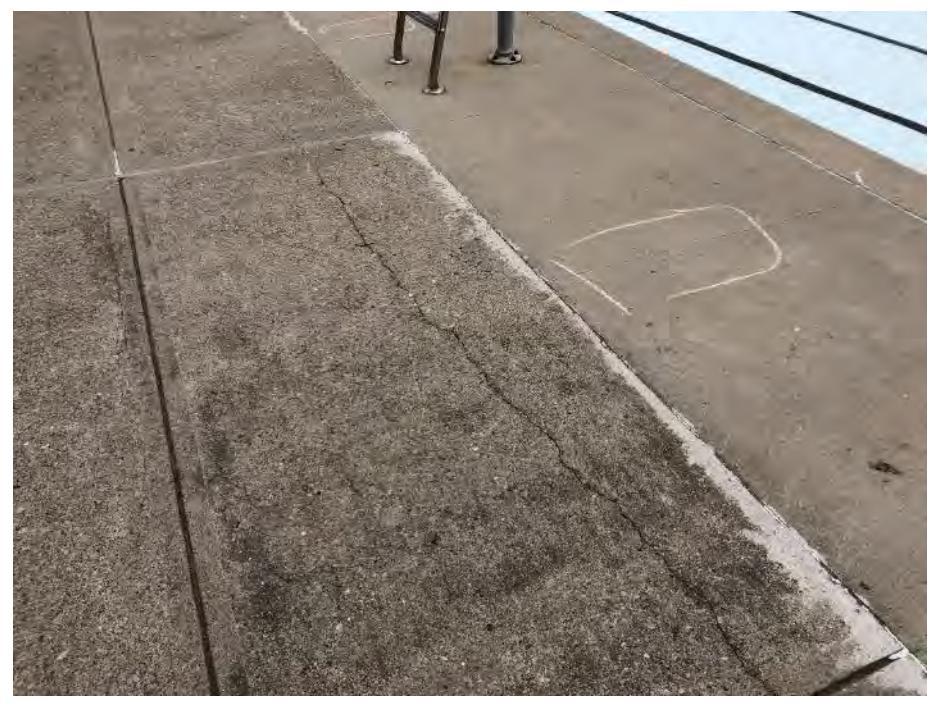
Photograph No. 9: Overview of pool deck cracks at west side.
