Public Report

То:	Joint Community Services/Finance Services Committee
From:	Ron Diskey, Commissioner, Community Services, Community Services Department
	Stephanie Sinnott, Commissioner, Finance Services, Finance Services Department
	Tracy Adams, Commissioner, Corporate Services, Corporate Services Department
Report Number:	CS-19-120
Date of Report:	October 2, 2019
Date of Meeting:	October 7, 2019
Subject:	Redevelopment Plan for Rotary Park
File:	E-4010

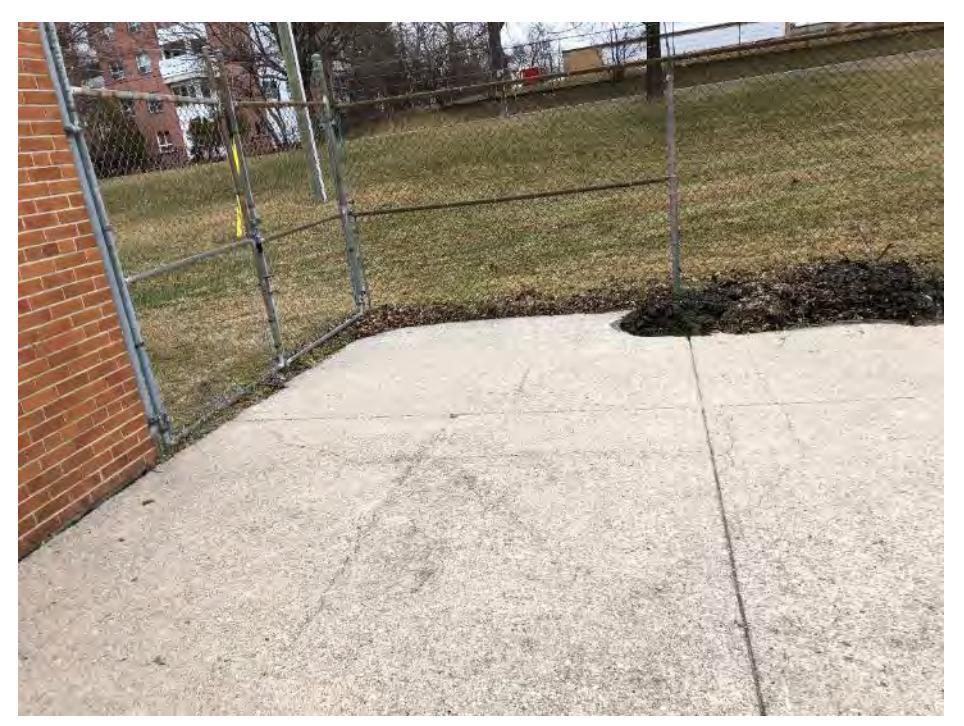
Photograph No.10: Overview of pool deck cracks at north-west corner.

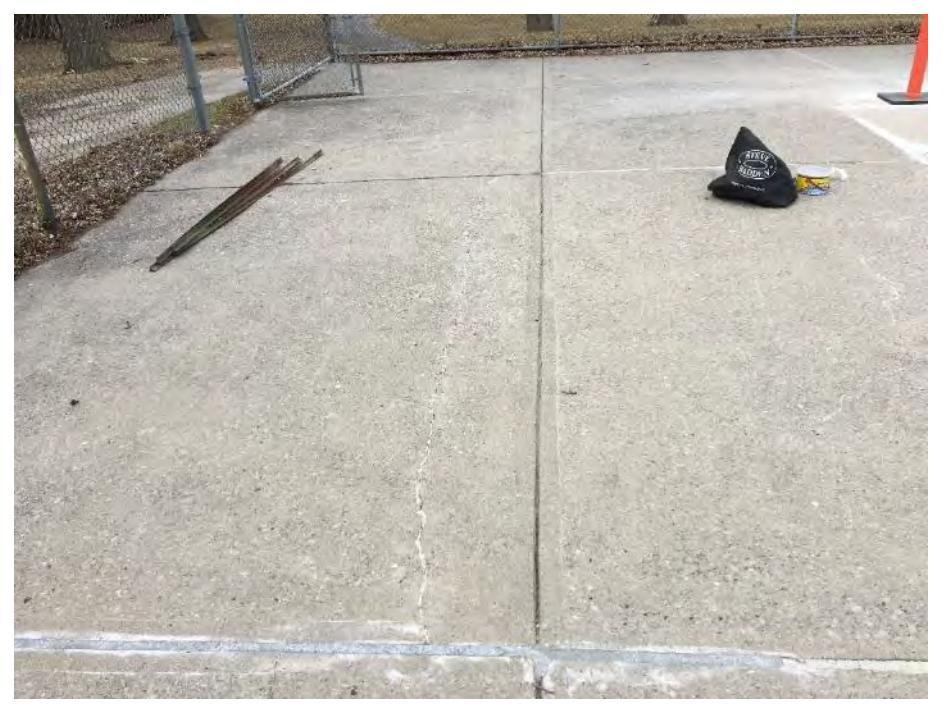
Photograph No.11: Overview of pool deck cracks on south side.

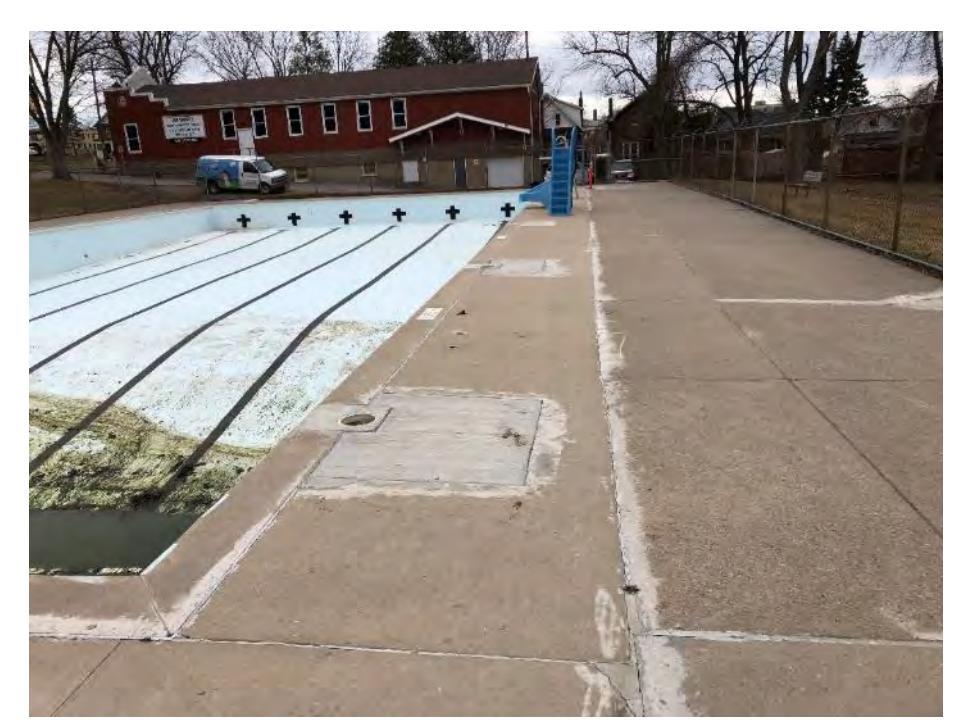
Photograph No. 12: Overview of pool deck sloping. Concrete panels appear to slope down to the right.

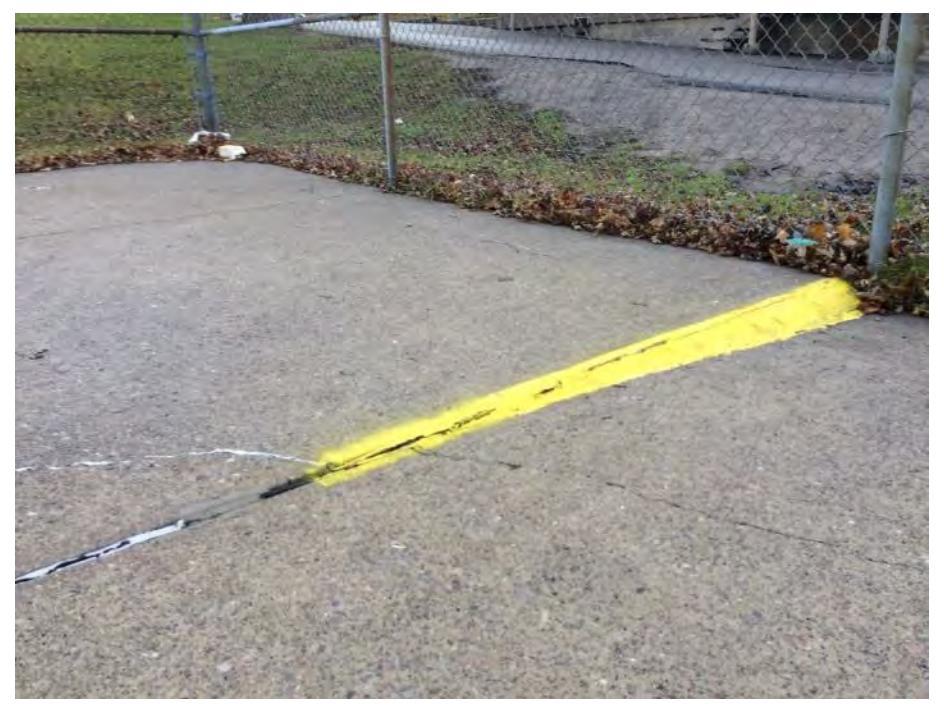
Photograph No. 14: Overview of tripping hazard concrete panel in 2016.

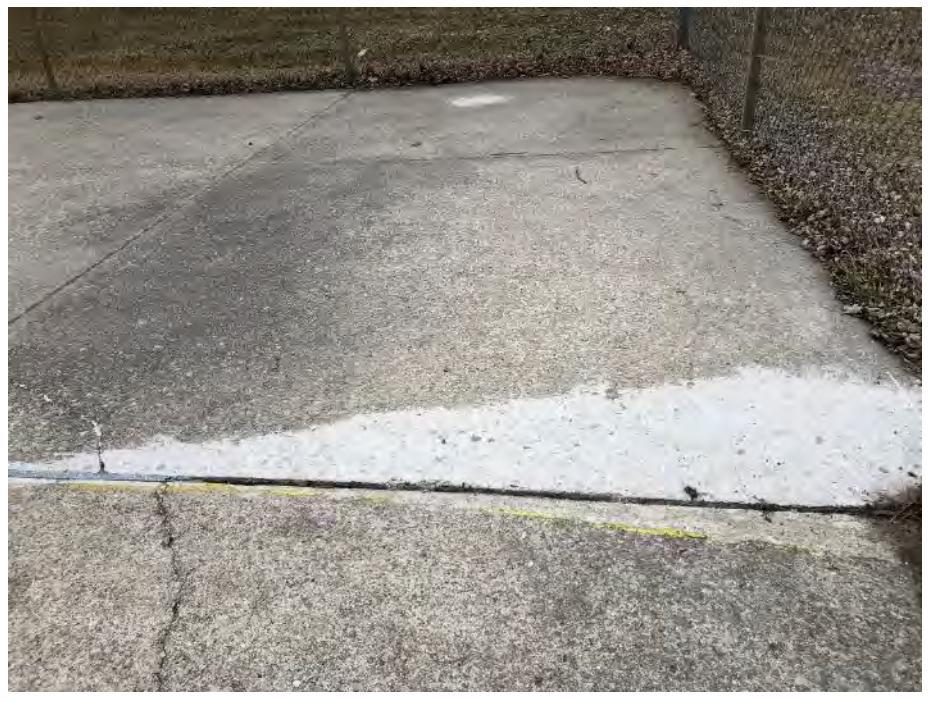
Photograph No. 15: Overview of ground concrete panel in 2019

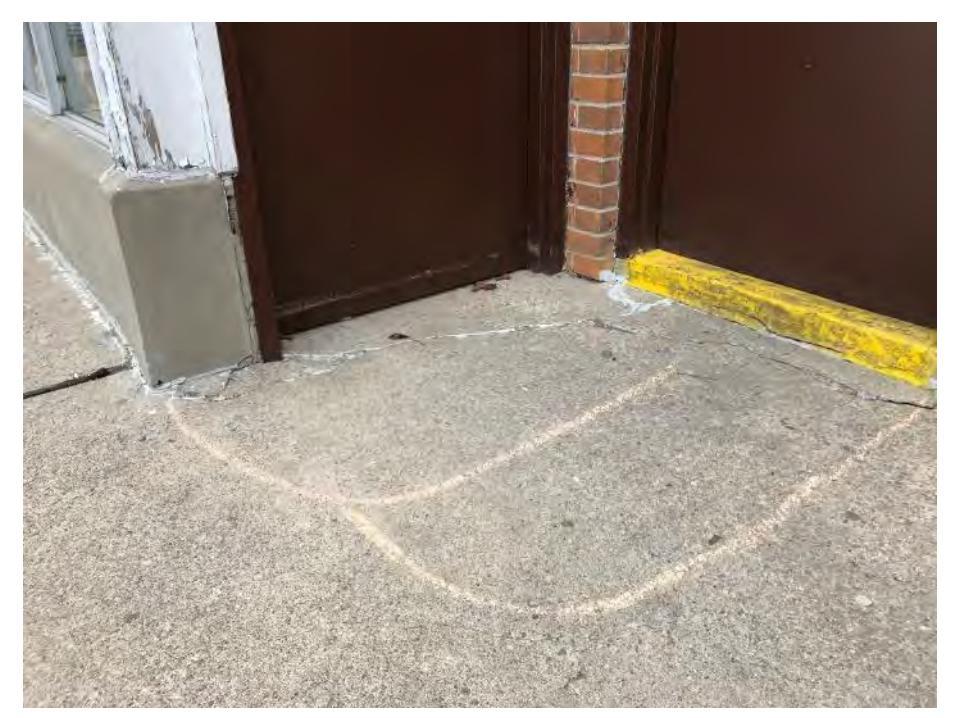
Photograph No. 16: Overview of cracked and sharp concrete panel at exit from Women's Change room.

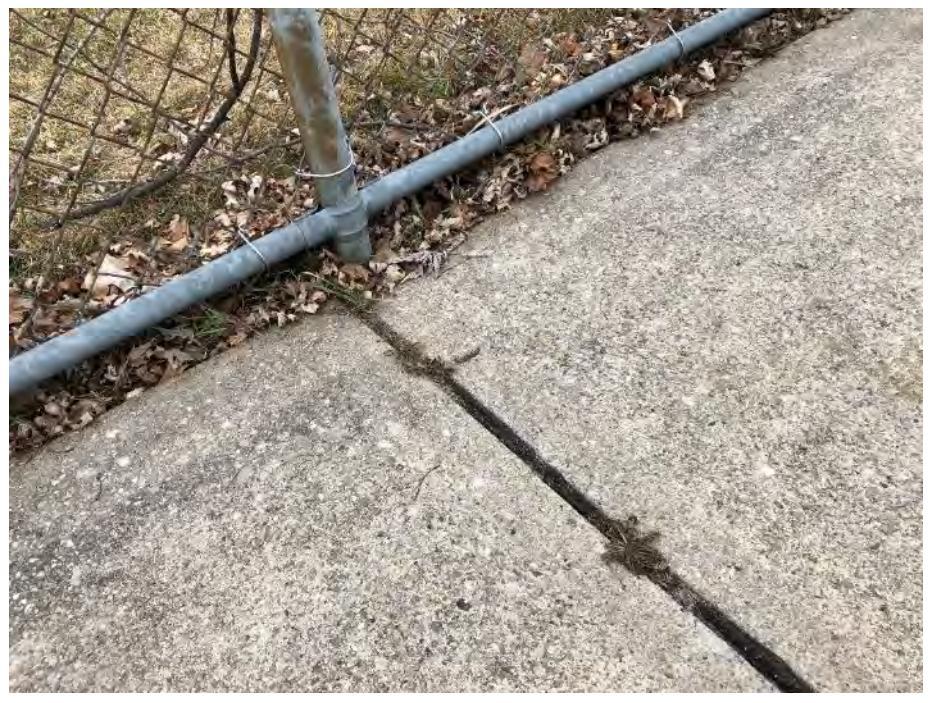
Photograph No. 17: Overview of plant growth and rubberized material in joint.

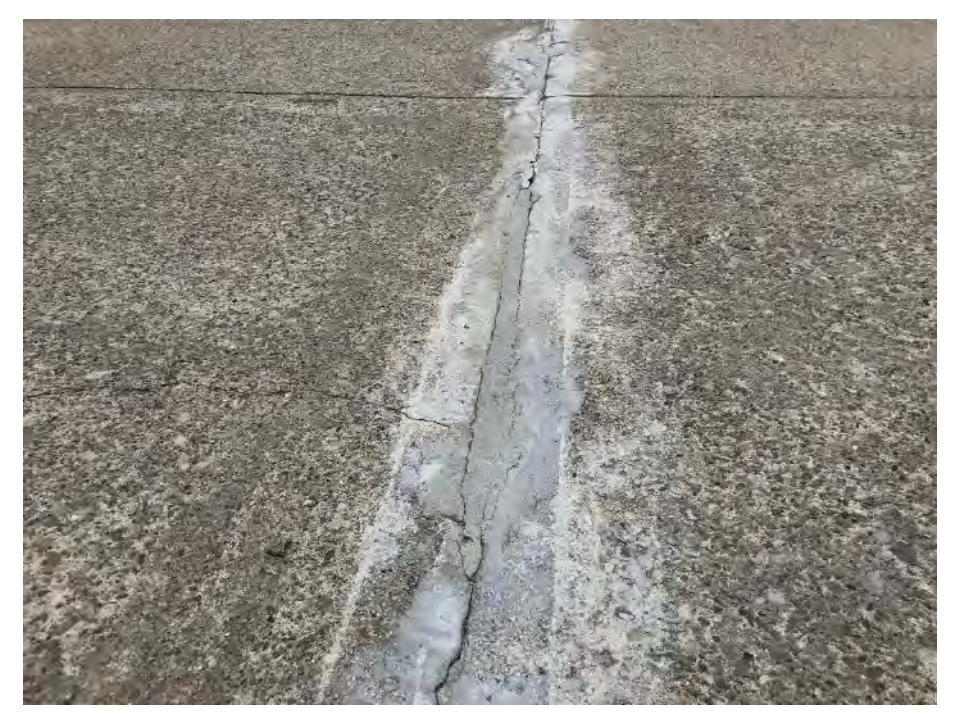
Photograph No. 18: Overview of failed joint filled with concrete

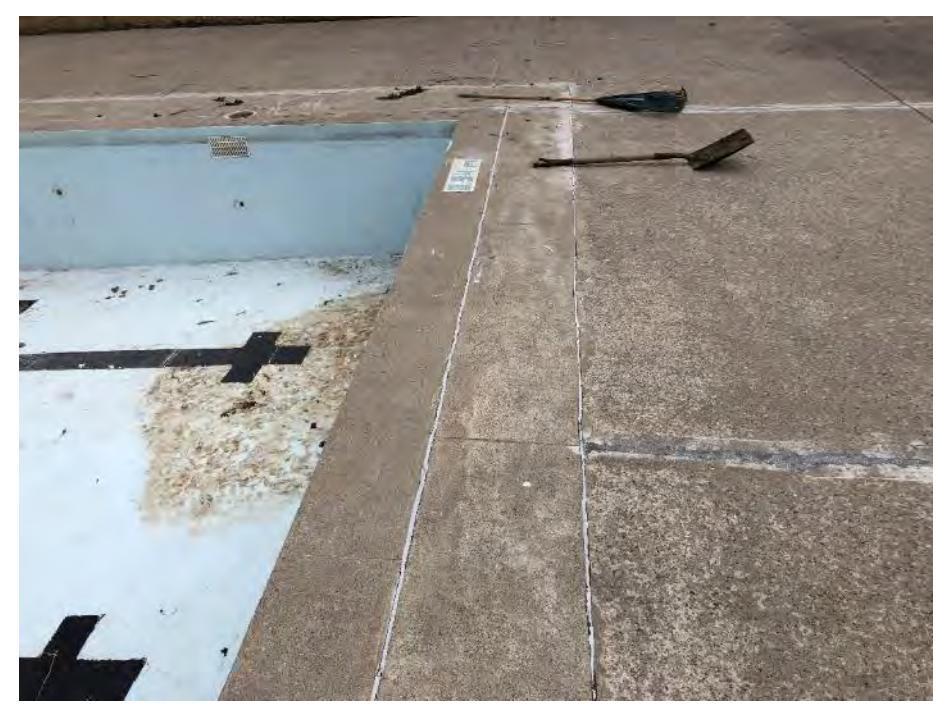
Photograph No. 19: Overview of failed caulking around perimeter of pool.

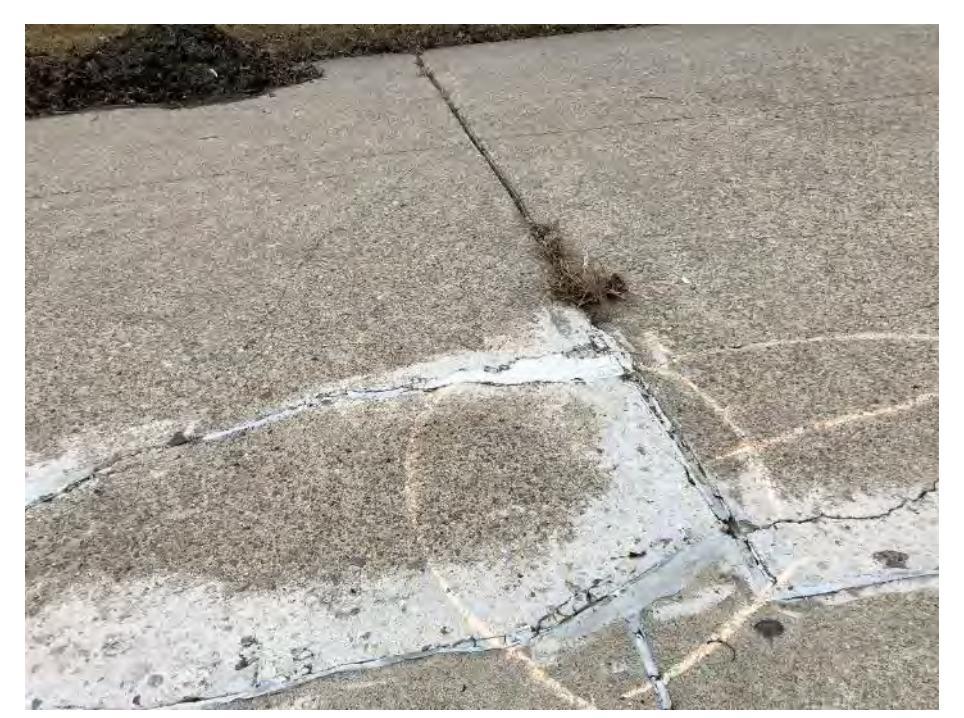
Photograph No. 20: Overview of plant growth within joint between concrete panels. Also note the cracked concrete panel and poor routing repair.

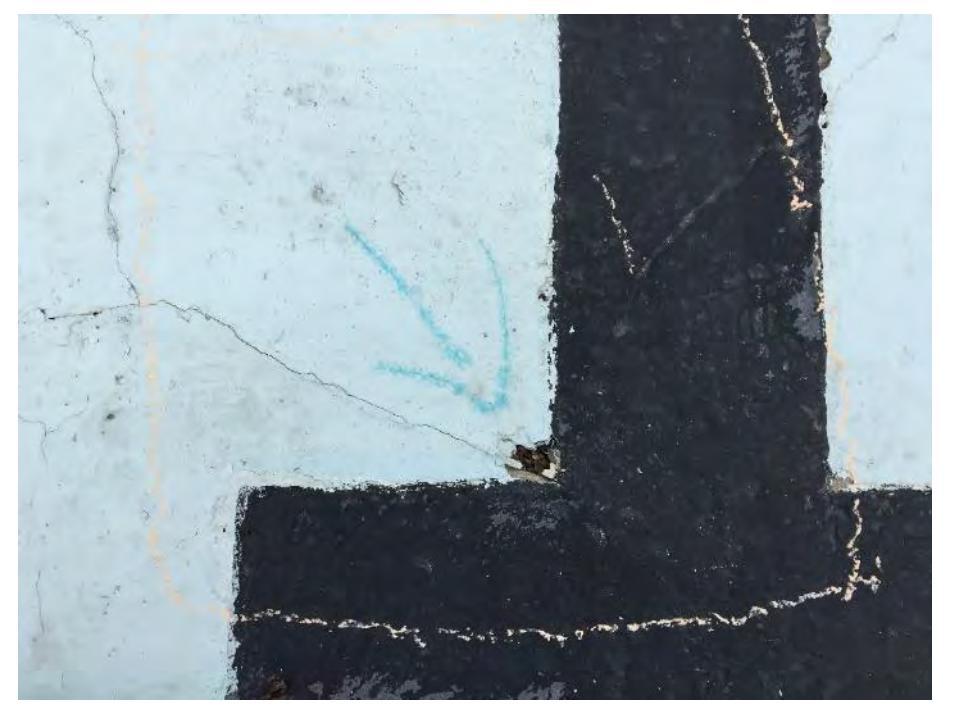
Photograph No. 21: Overview of surface delamination within pool.

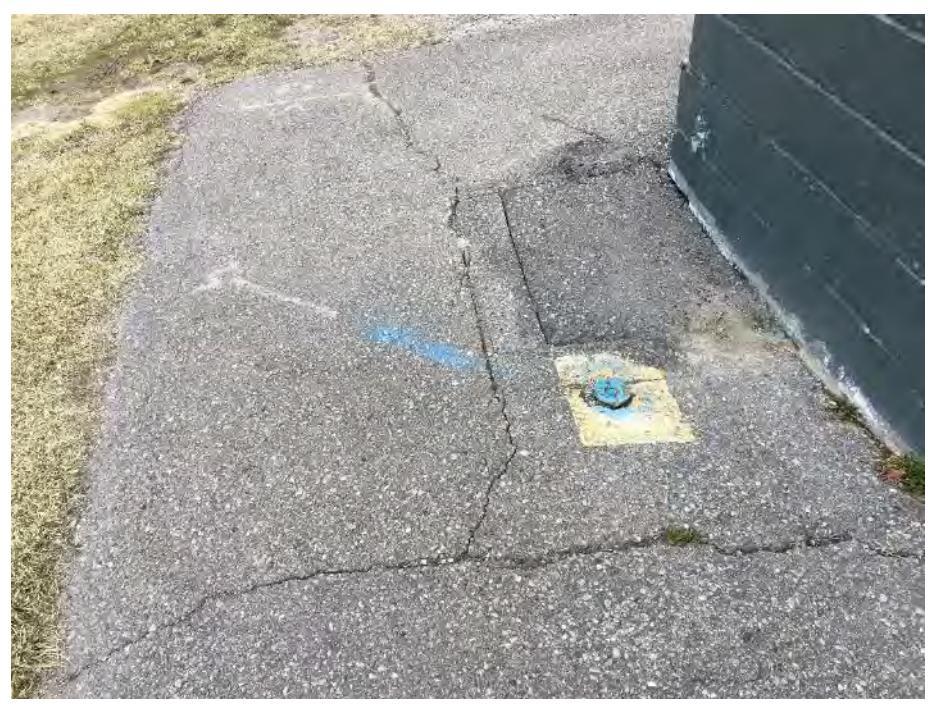
Photograph No. 32: Overview of asphalt settlement and alligator cracking.
