То:	Community Services Committee
From:	Ron Diskey, Commissioner, Community Services Department
Report Number:	CS-21-28
Date of Report:	March 17, 2021
Date of Meeting:	March 22, 2021
Subject:	Phased B.M.X. Bike Park Facility
File:	F-6105

Site Assessment and Recommendations Plan

'Greenland' Bike Track Facility

Prepared by: Transitions Bike Parks Inc.

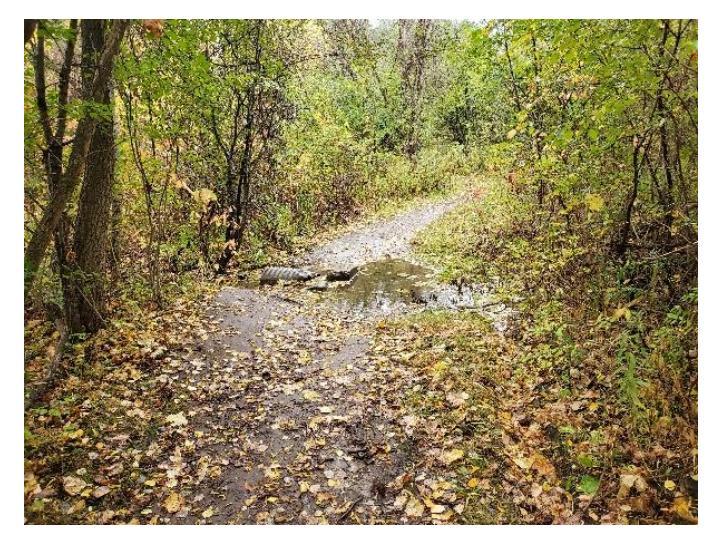
Site Visibility

Visibility to the track area is low, except for a portion of the adjacent Oshawa Airport golf course that directly abuts the site. This characteristic was likely considered to be an asset for the original development of the track, where its informal creation could carry on relatively unnoticed and without disturbing nearby residents, which is very similar to most types of informal BMX style jump tracks. From the municipality's standpoint however, the low visibility presents a concern for CPTED, general awareness of the facility, and safety in the event of someone being injured without being noticed by passersby. Although the physical location of the site cannot be changed,

consideration should be given to increasing the awareness of the facility.

*Signage indicating emergency contact phone numbers, municipal addressing and general safety regulations should be posted in key locations on the site to mitigate risk.

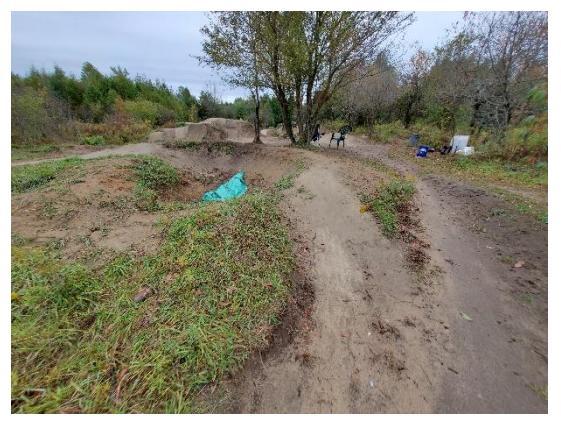
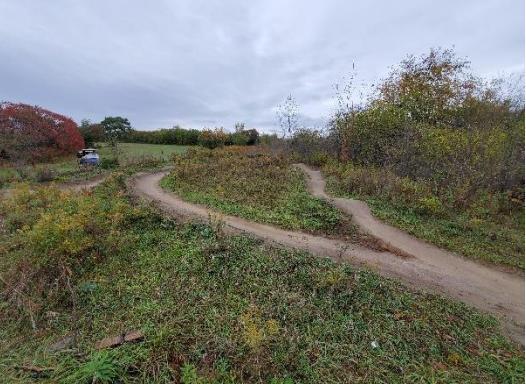
Neighbouring Land Uses

As noted, the site is adjacent to a portion of the Oshawa Airport golf course and remains the only opportunity for visibility into the site from the public and is separated by an approximately 3-4' tall post and wire fence. Further, the area visible to the golf course is near the track staging area, where riders begin their runs, congregate and store personal belongings. There is also an informal garbage collection, rain barrel and tool storage area at this location currently, and it can be reasonably perceived that the portion of track visible to the golf course may appear to be somewhat of an eyesore to non-users, particularly in contrast with a manicured golf course.

Further, due to the different types of recreational uses and their proximity to each other, a small opportunity exists for potential conflict between opposing user types such as unwanted noise or disruption leading to verbal exchanges, as there have been concerns alleged of minor disruption or mischief on the golf course possibly by track users, which has led to some complaints at various times.

*Repairs or improvements to the fence between properties is recommended, with consideration being given to a privacy screening material or mesh to limit visual impact to surrounding properties, while maintaining several locations of visibility into the site for safety and awareness purposes. Simple signage on the track side of the fence is also recommended, with wording that could include 'please keep off the golf course' or 'please respect the neighbours'.

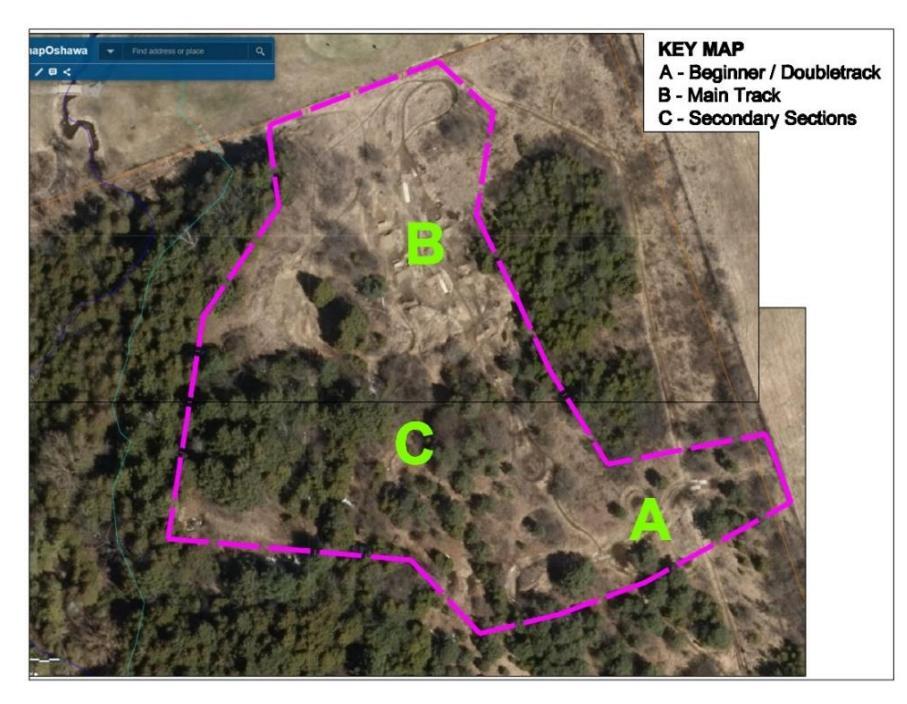
The existing system of trails has been organically developed over a period of multiple years by a variety of local riders and user, and as a 'grassroots' initiative it has been constructed intermittently and built using hand tools only, with materials extracted from the site and surrounding area. For simplicity and reference purposes, the track can be divided into 3 general areas as noted:

A – Beginner doubletrack area. This section can be found when entering the site and is comprised of 2 linear sections that run side by side, allowing two riders to travel side by side, and consists of small to medium sized, rolling features.

B – Main Track. The main track area occupies most of the site and has been the focus of the local riders' efforts. This portion of the track is built in the open space area and has several individual lines and options and consists of intermediate to advanced level features.

C – Secondary Sections. There are a handful of other smaller sections adjacent to the main track site that have received a fair amount of attention and maintenance, and include a rolling 'rhythm section' ending in a concave bowl, and a large 'step up / style jump' that is accessed from a long downhill runway. These sections consist of mainly intermediate level features, with the large step up jump being described as intermediate / advanced.

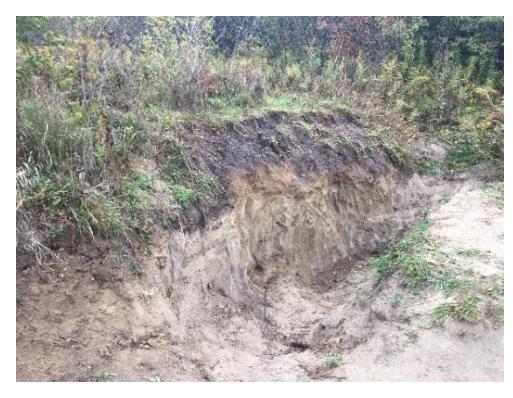
Weaknesses and Concerns - General Site Construction

As the track has been created using hand tools such as shovels, wheelbarrows and rake, with material extracted from around the site only (as opposed to imported fill) there are several areas that have open extraction pits that have been created by the riders in order to harvest the necessary material to construct the track and features.

Several smaller, shallower areas are evident around the site and pose less concern than deeper, steeper pits that pose a significant fall concern.

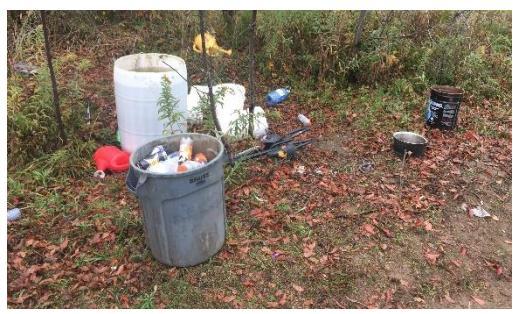
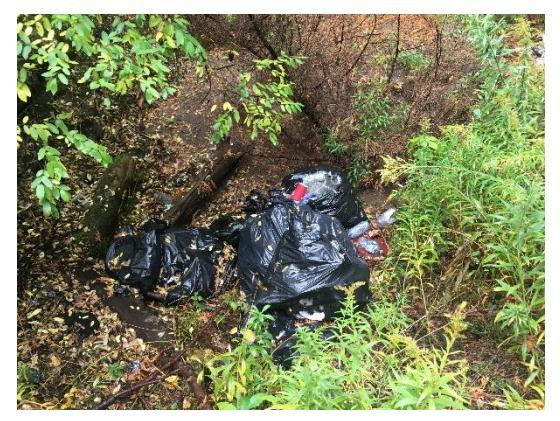
Garbage / Waste Collection

An obvious area of concern to the average person is any accumulation of garbage and recycling that may be visible from time to time and was present during our inspection. Most items observed during our inspection appeared to be recyclables such as drink containers and garbage such as food wrappers and product packaging.

An informal collection area was observed near the main staging / starting area and was visible from the adjacent golf course. At the time of inspection, a small amount of garbage overflowing the bin was observed, and accessory tools such as watering cans, buckets and a rain barrel could potentially be mistaken for additional garbage.

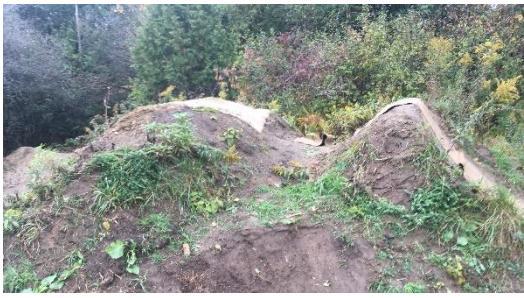
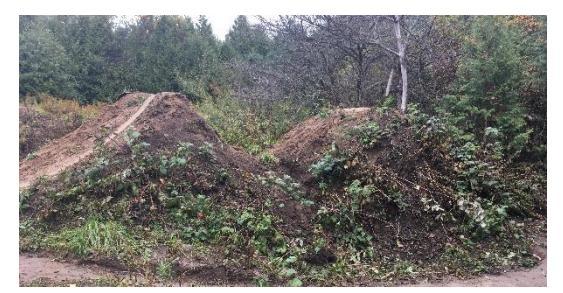
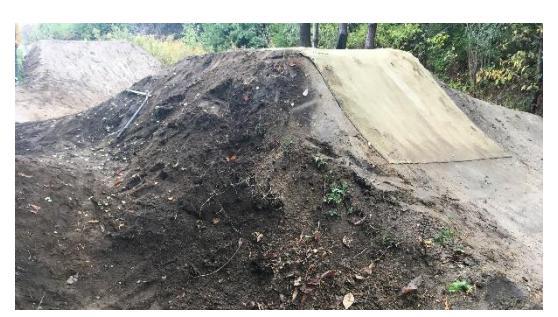
Gaps

Safety and sustainability of features is a key concern of these types of facilities. Often due to the limited availability of building materials, one of the biggest and most common concern is the presence of gaps on jump features between take offs and landings. These gaps are the result of limited material and that they are not entirely required from a riding perspective, as the jumps are intended to be 'cleared' by intermediate and advanced riders when riding at the appropriate speeds.

When travelling at lower speeds, or being ridden by younger or less skilled riders, features with the middles filled in to create 'tabletop' jumps or with more shallow, rollable jumps such as 'rolling doubles' allow users to rider over the top of the jump without consequence, in case of user error or hesitation.

*Infilling centre gaps or pits on all jump features is recommended, to a maximum dip of 40cm.

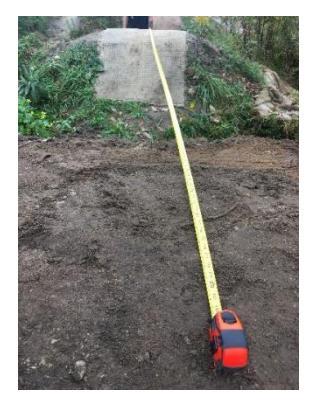
Feature Widths

Another source of potential safety and stability concerns can be found on the width of features. With the common theme of limited material, time and human resources available, the width of many features is often reduced in order to save valuable material and time, particularly on landing features. Several areas on the track were noted to have narrow landings, that can cause concern if riders veer of course in mid air and landing on the sides or off the landings.

*Features should be widened to the minimum recommended width, where needed.

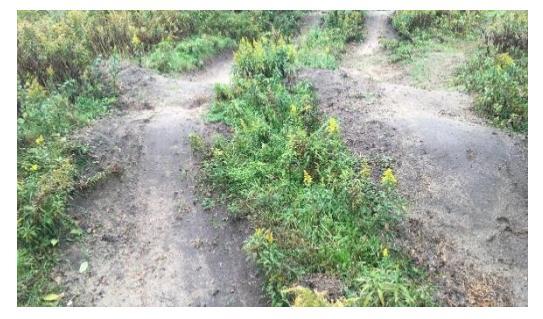
Feature Lengths

Feature widths were determined to be overall quite reasonable, with a maximum horizontal gap distance of approximately 13'. This length could be considered the maximum safe length for an advanced level feature at this type of facility, depending on the individual feature characteristics and placement of the feature. Maximum length features were found in the main track area, toward the end of the sections, where riders can be expected to have committed to the line and know what to expect upon progressing down the line. A similar 13' length feature was found on the Secondary track area C - with the 'step up' feature measuring approximately 13' distance with about 4' of elevation change.

*Jump features should be kept to a maximum 'gap length' of 12-13' or less, depending on the individual requirements, assuming the centre gaps are filled in, and with appropriate 'case plates' built on landings to increase safety and allow riders a greater margin of error.

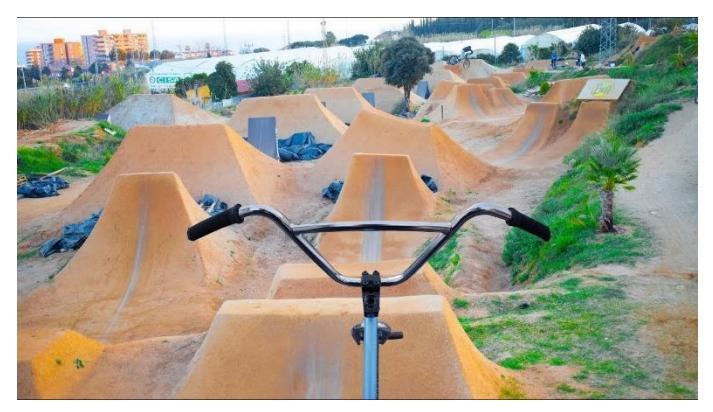
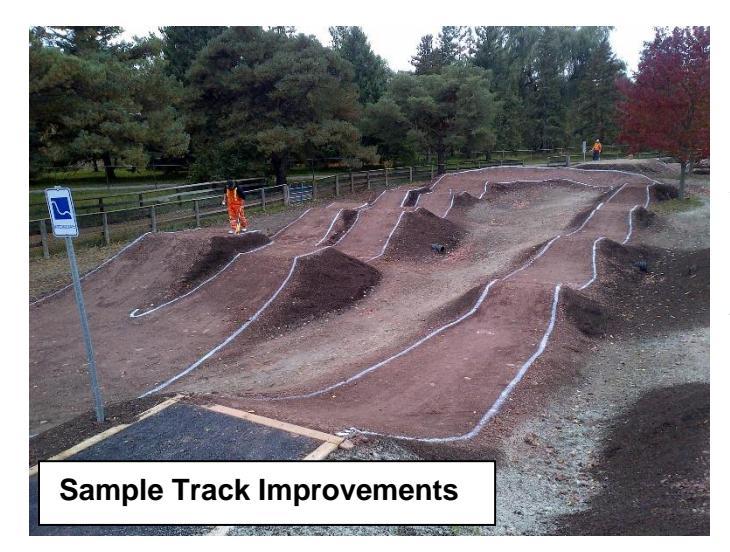
Feature Shapes

Feature shapes were determined in several spots to be irregular or misshapen, on the overall feature and most importantly on the riding surface itself which is likely due to a combination of age, weathering, erosion, limited maintenance and riding damage.

Carpets were also noted on several features to limit damage from erosion and riding. To preserve the intended shape, appearance, and durability of all riding features, a consistent, uniform and somewhat manicured shape is to be strived for, which will enhance the overall appearance and functionality of the site.

*Reshaping, minor adjustments / modifications, grooming, maintenance, and general improvements are recommended throughout the site where required, with additional attention being given toward lesser used and beginner level features that have seen less work and focus.
