Public Report

То:	Joint Community Services/Finance Services Committee
From:	Ron Diskey, Commissioner, Community Services, Community Services Department
	Stephanie Sinnott, Commissioner, Finance Services, Finance Services Department
	Tracy Adams, Commissioner, Corporate Services, Corporate Services Department
Report Number:	CS-19-120
Date of Report:	October 2, 2019
Date of Meeting:	October 7, 2019
Subject:	Redevelopment Plan for Rotary Park
File:	E-4010

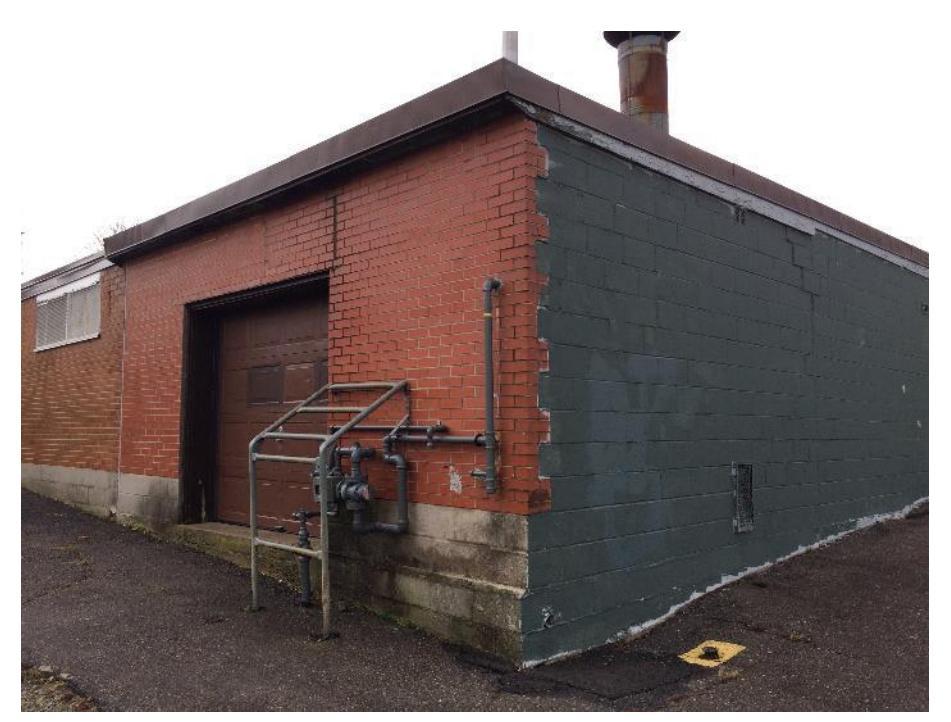
Photograph No. 3: Overview of Mechanical Room

This Change Room Building is divided into two areas; the change room facilities, which are accessible to the public/users of the facility, and a mechanical room only accessible to maintenance personnel (*Refer to Photograph No. 3 in Appendix A*).

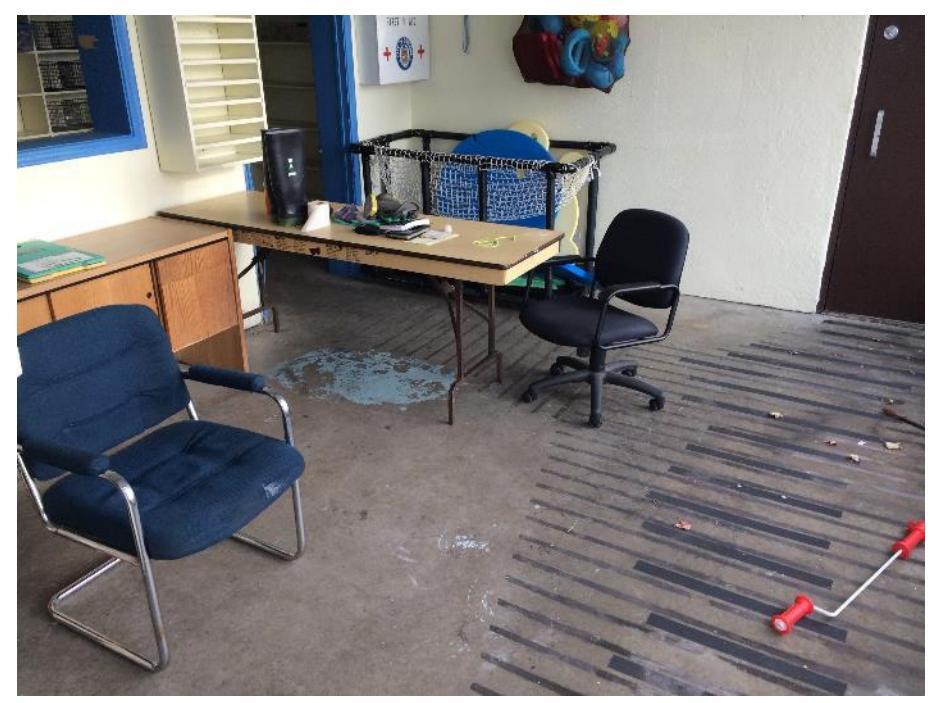
Photograph No. 6: Overview of Concrete Slab-on-Grade - Original Building

The original building is a single-storey building with a rectangular footprint with approximate plan dimensions of 35 feet in the north-south direction and 45 feet in the east-west direction. Based on our observations of site, the original building is of combination of traditional masonry and timber and structural steel framing construction (*Refer to Photographs No. 4 to 5 in Appendix A*). The foundation walls of the original building appear to be of concrete block construction. The floor of the original building is concrete slab-on-grade (*Refer to Photograph No. 6 in Appendix A*).

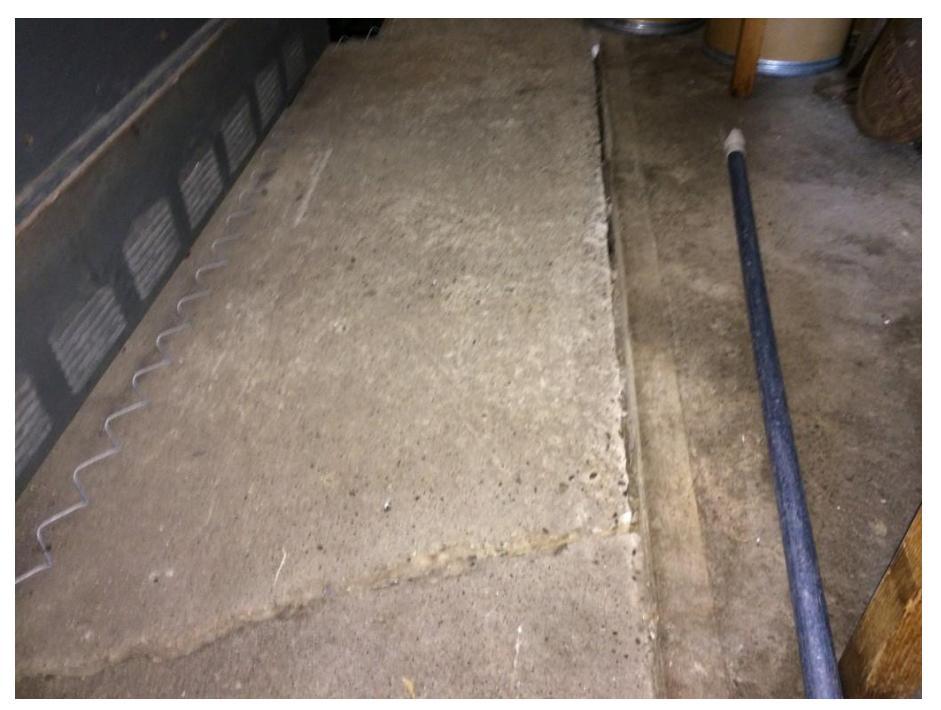
Photograph No. 10: Overview of Concrete Slab-on-Grade – Mechanical Addition

The Mechanical Room addition to the west of the original building is a single storey structure with a rectangular footprint with approximate plan dimensions of 35 feet in the north-south direction and 20 feet in the east-west direction. The exterior walls are of a combination of concrete block (west elevation), concrete block with a brick veneer (north elevation) and multi-wythe brick (south elevation) (*Refer to Photographs No. 7 to 9 in Appendix A*). Based on our observations made on site, the floor of the Mechanical Room consists of a concrete slab-on-grade which appears to have been cast in two separate pours (*Refer to Photograph No. 10 in Appendix A*).

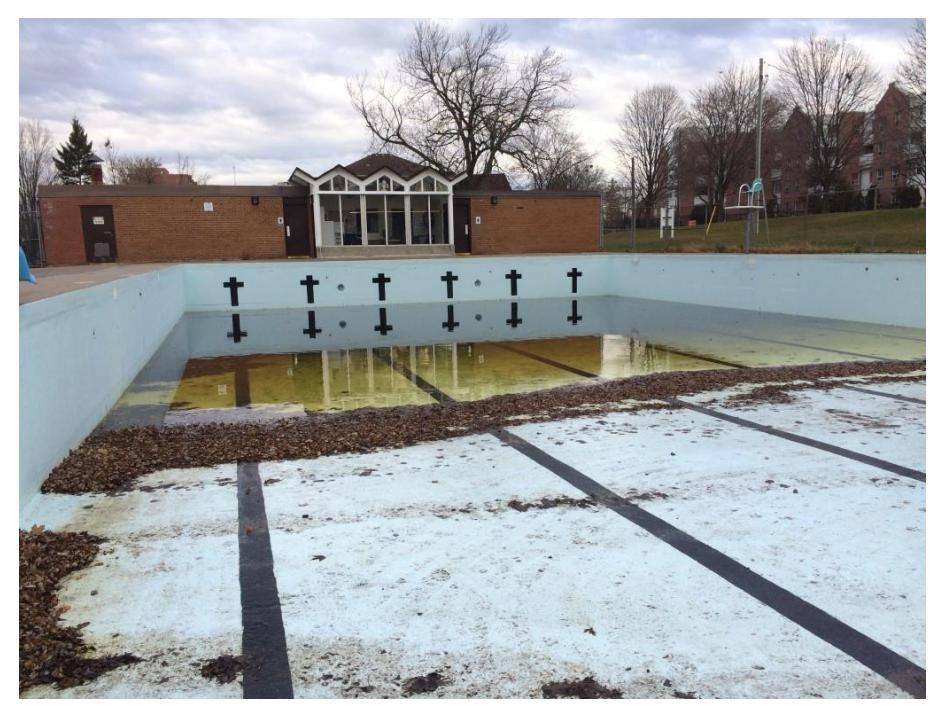
Photograph No. 12: Overview of Pool Structure

The outdoor pool appears to be of normally reinforced cast-in-place concrete construction surrounded by on-grade cast-in-place concrete pool deck (*Refer to Photograph No. 12 in Appendix A*). No information with respect to the original construction detailing of the pool structure was available for our review.

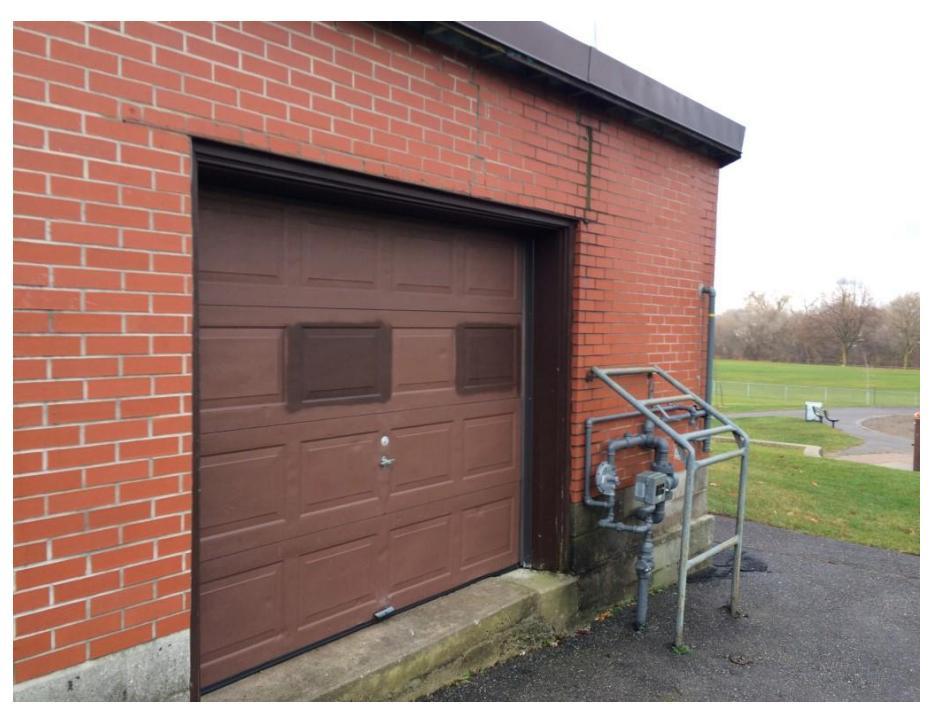
The exterior walls of the mechanical room were noted to be in various state of repair, ranging from fair to poor condition. The north and south exterior walls were observed to be in fair condition exhibiting evidence of localized distress in the form of spalled and cracked mortar joints, step cracking of brick veneer and localized spalling of the brick (*Refer to Photographs No. 23 and 24 in Appendix A*).

Photograph No. 23: Overview of North Exterior Wall – Mechanical Room

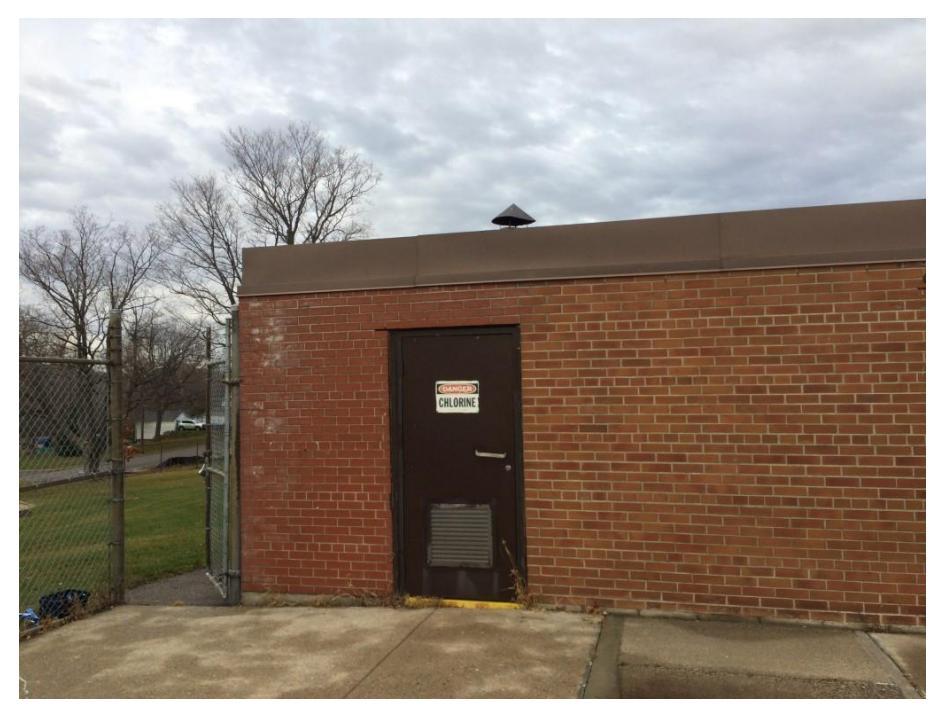
Photograph No. 24: Overview of South Exterior Wall – Mechanical Room

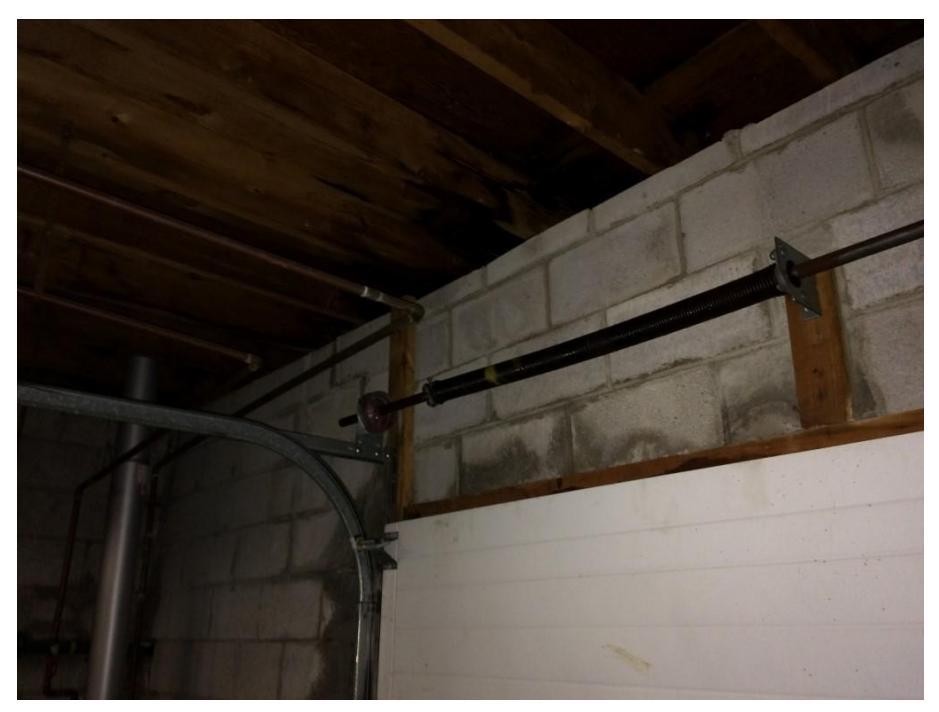
Photograph No. 30: No Crack on Block Wall above Overhead Door - Mechanical Room Interior

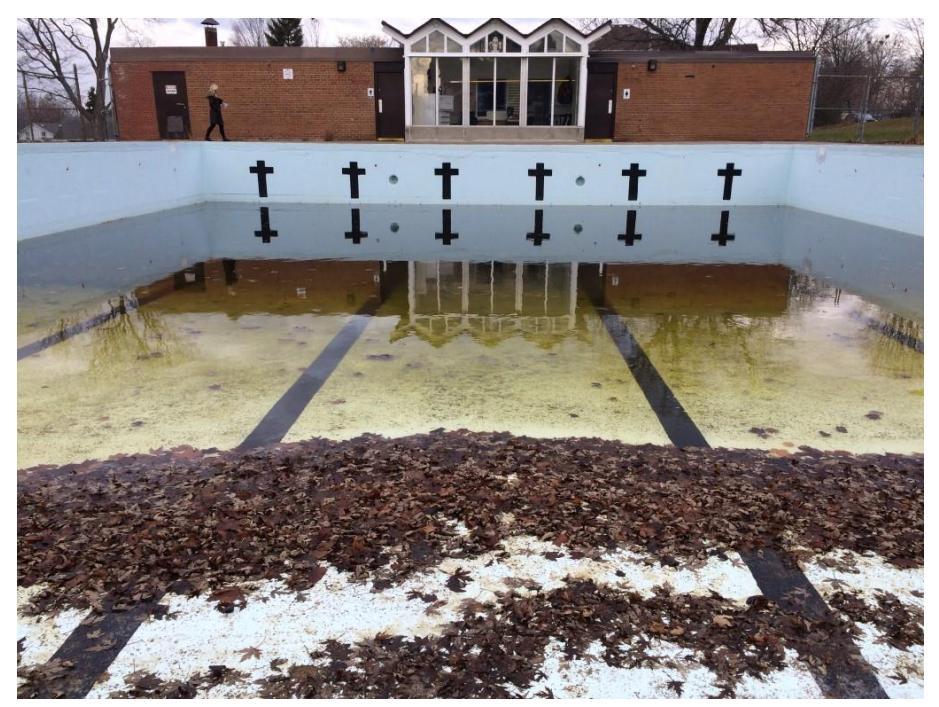
Photograph No. 34: Run-off Water in the Pool during Site Visit

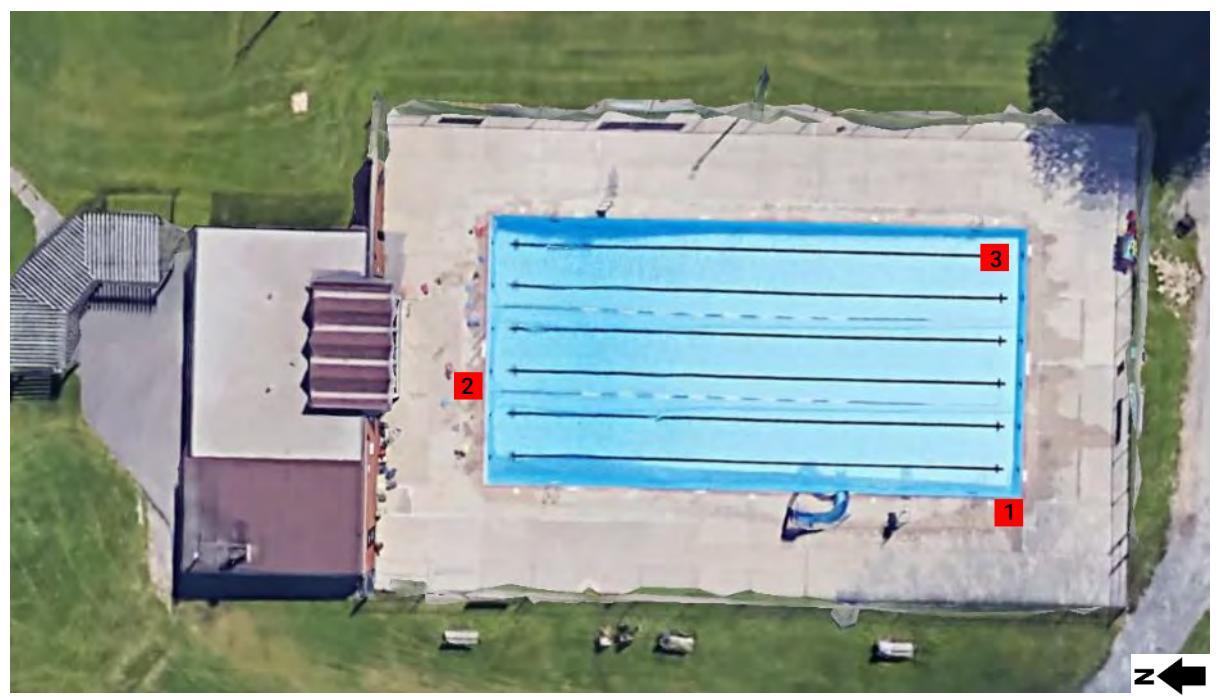
Figure 6 - Overview of Rotary Pool Test Pit Locations

Test Pit Number/Location	Observations
1 –South-West Corner of pool deck. (Refer to	-6-inch thick concrete panel
Photographs No. 23 to No.25 in Appendix A).	-steel reinforcement noted in North-South
	Direction within concrete panel
	-Did not appear to be voids present beneath
	concrete panel
2 –North side of pool deck. (Refer to	-7-inch thick concrete panel
Photographs No. 26 to No.28 in Appendix A).	-steel reinforcement noted in North-South and
	East-West direction within concrete panel
	-Appeared to be a 1 to 2-inch void present
	beneath concrete panel
3 – South-east corner of pool tank (Refer to	-2-inch thick concrete delamination lifted off
Photographs No. 29 and No.30 in Appendix A).	the top of the test opening
	-Remainder of concrete tank slab appeared to
	be in solid condition

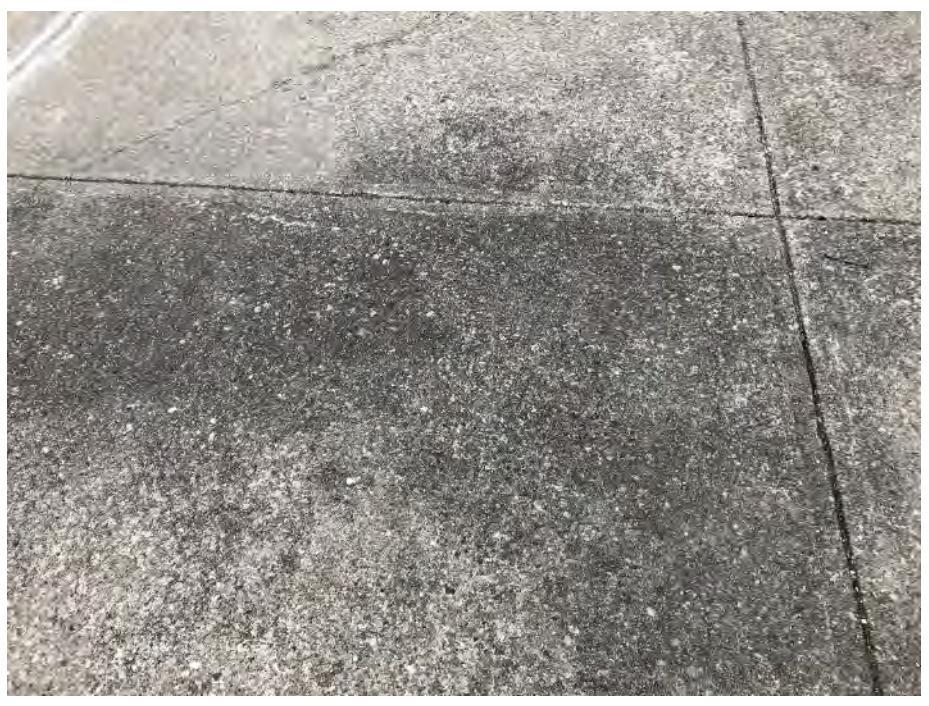
the panels directly adjacent to the pool (*Refer to Photographs No.12 in Appendix A*). RJC also reviewed the surface finish of the panels and noted heavy pitting in the south-east corner (*Refer to Photographs No.13 in Appendix A*). Localized areas on the pool deck appeared to have been grinded down to facilitate a smooth walking surface for patrons of the pool, as compared to our 2016 review when the surface appeared to be sharp (*Refer to Photographs No.14 and No.15 in Appendix A*). RJC also noted localized areas in which the panels appeared to be cracked and present a safety hazard to patrons of the pool (*Refer to Photographs No.16 in Appendix A*). Approximately 17 sq.ft of visually obvious cracked/spalling panel sections were also observed.

Photograph No. 13: Overview of surface pitting at south-east corner.

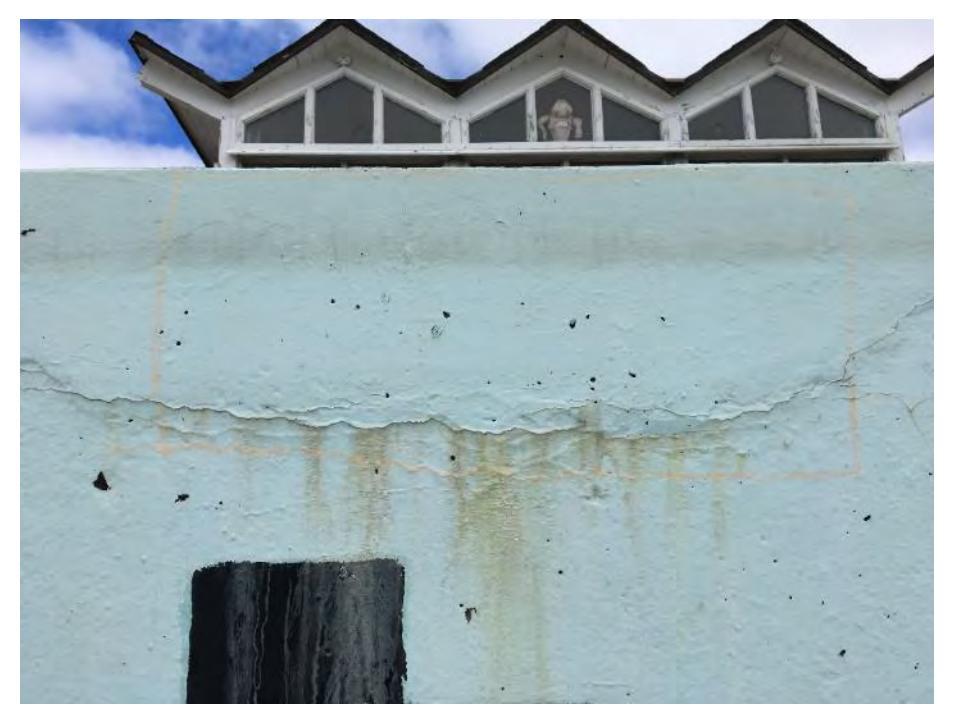
70 sq.ft of hollow sounding areas within the pool tank (*Refer to Figure 5 and Photograph No. 21 in Appendix A*).

Photograph No. 21: Overview of surface delamination within pool.

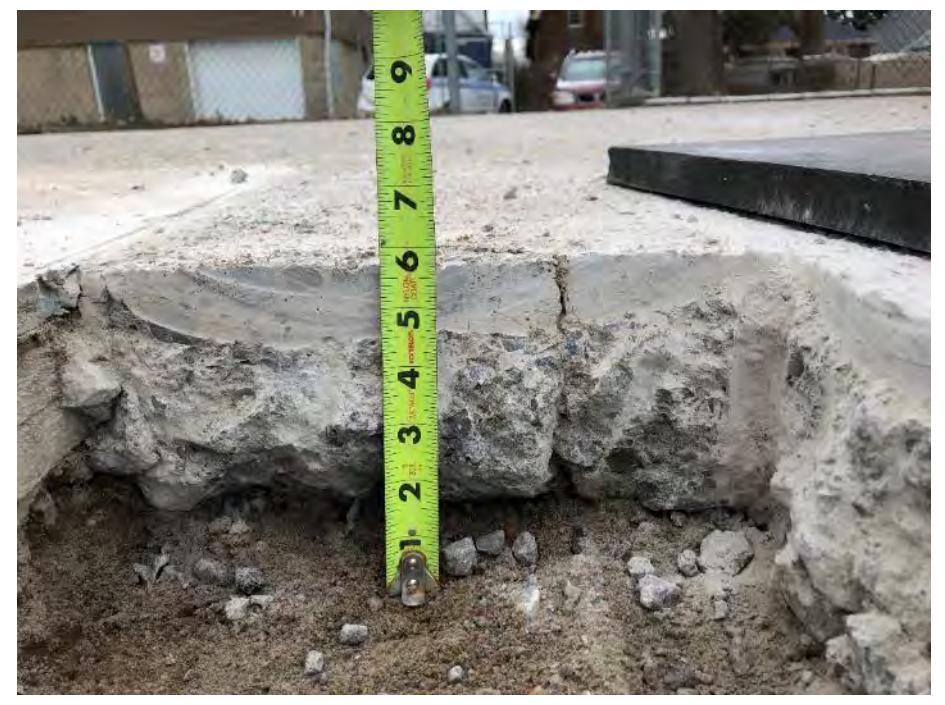
Photograph No. 23: Overview of Test Pit 1.

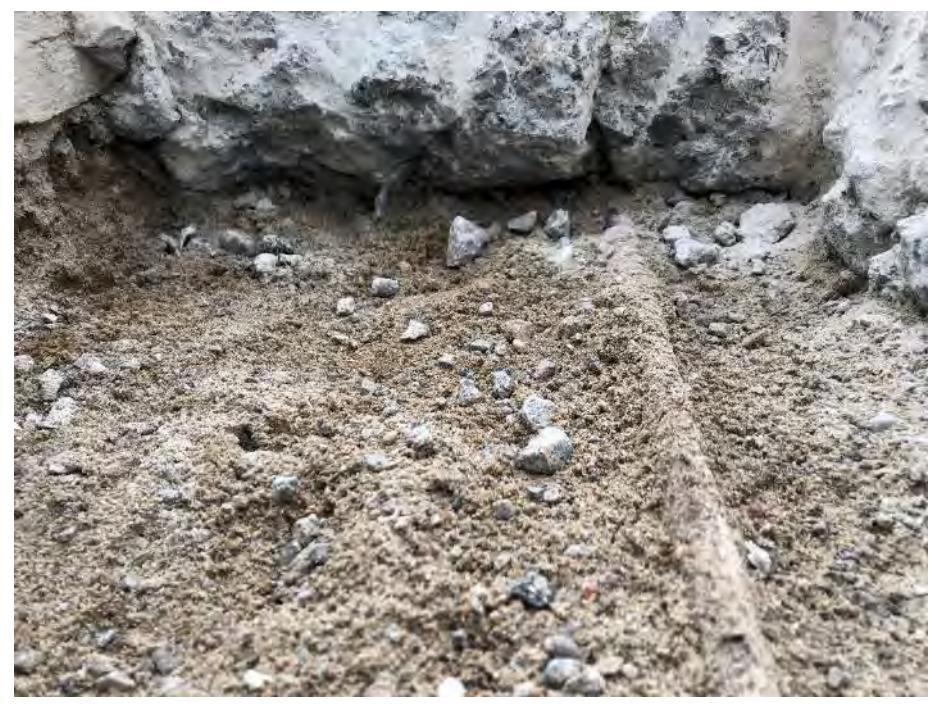
Photograph No. 24: Overview of Test Pit 1.

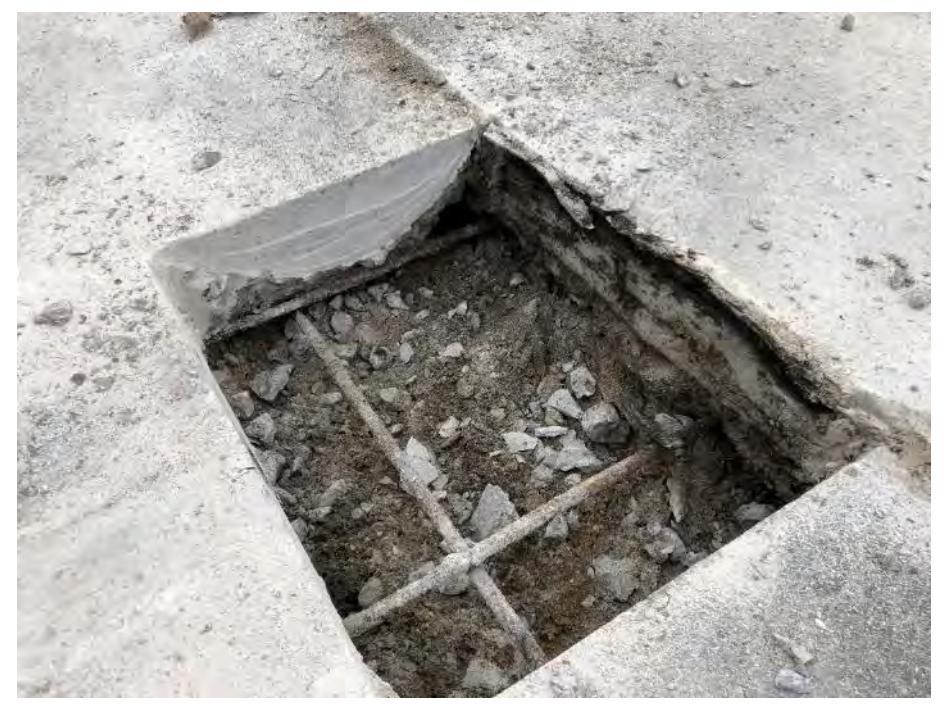
Photograph No. 26: Overview of Test Pit 2.

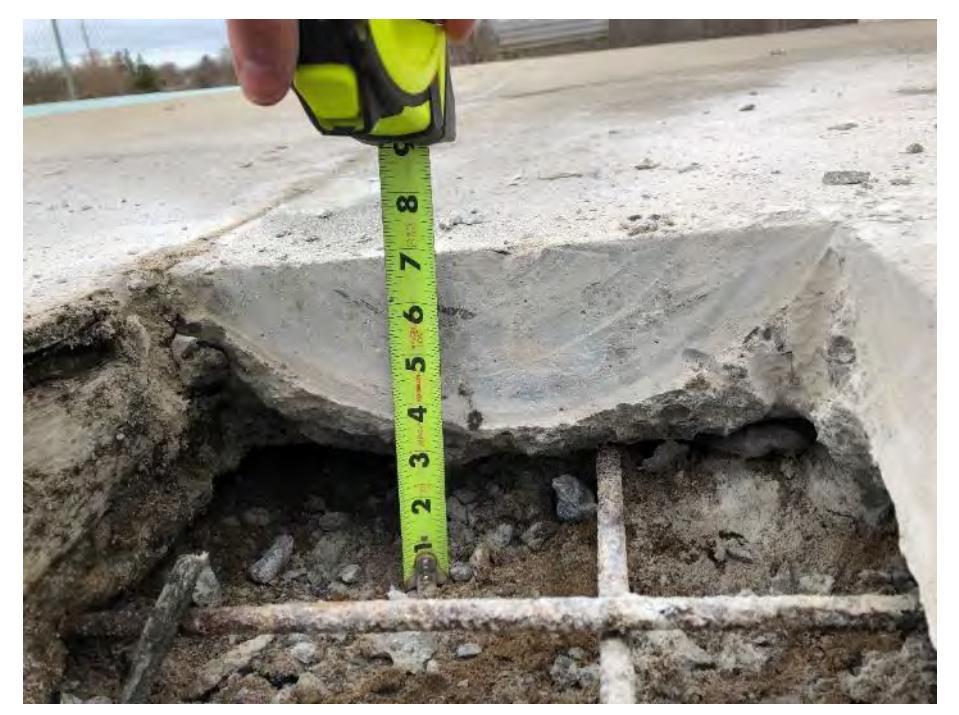
Photograph No. 27: Overview of Test Pit 2 steel reinforcement.

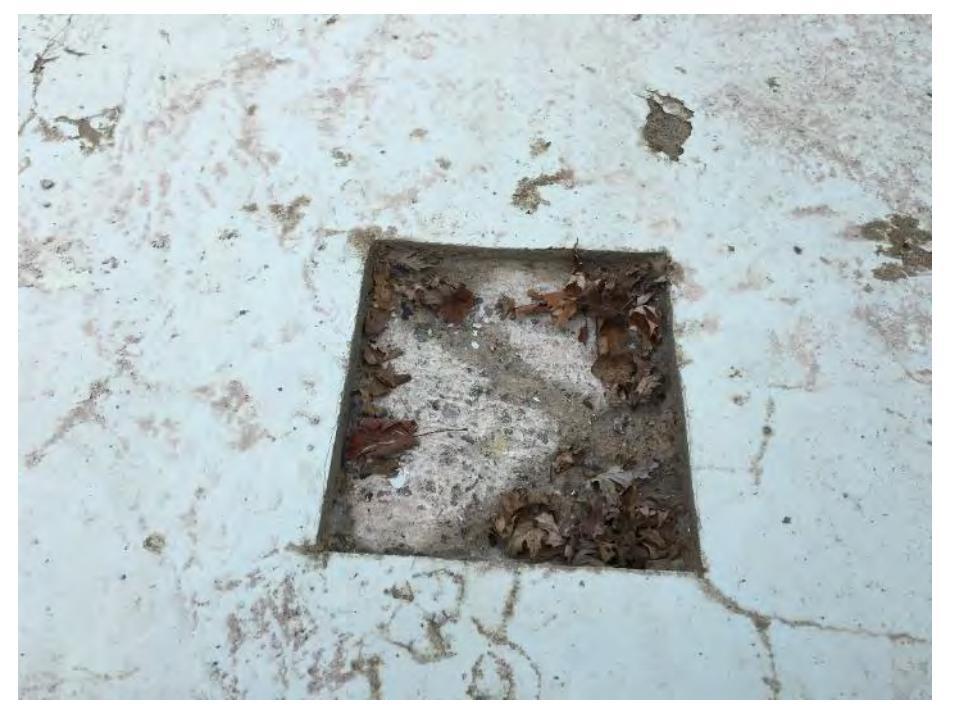
Photograph No. 28: Overview of Test Pit 2. Note the void space underneath the concrete panel.

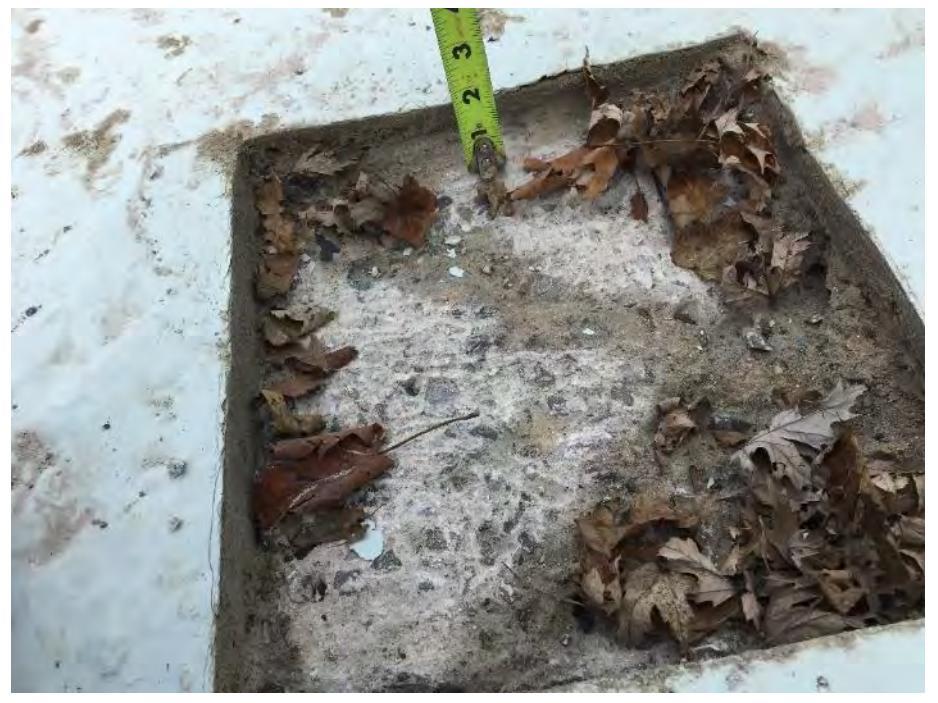
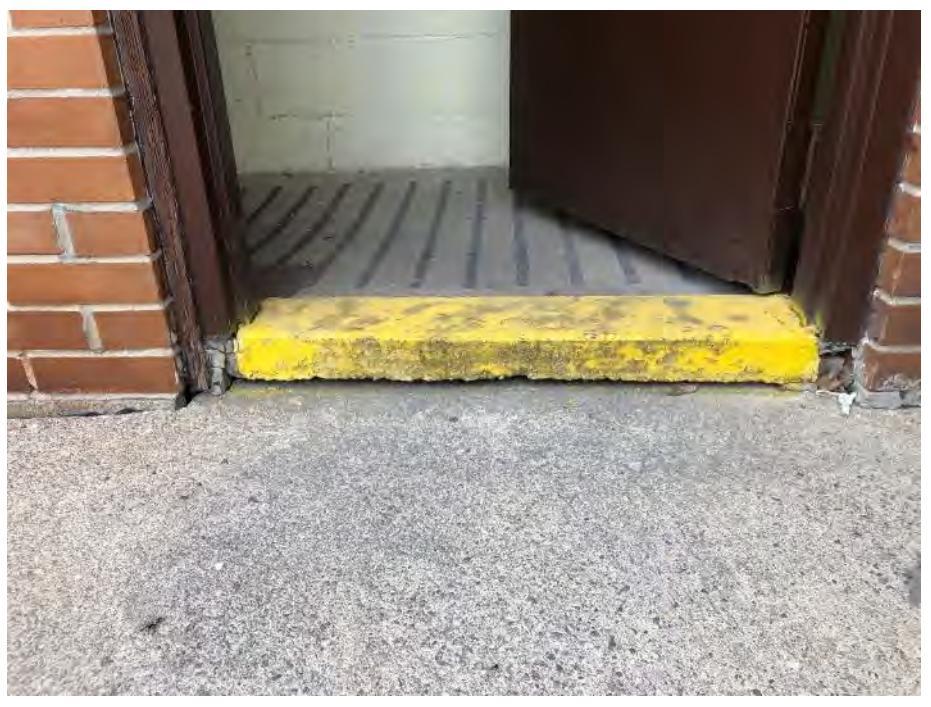
Photograph No. 29: Overview of test Pit 3 within pool.

Photograph No. 30: Overview of test Pit 3 within pool.
